CABINET MOUNTAINS WATER DISTRICT

WATER SYSTEM FACILITY PLAN UPDATE

APRIL 2020

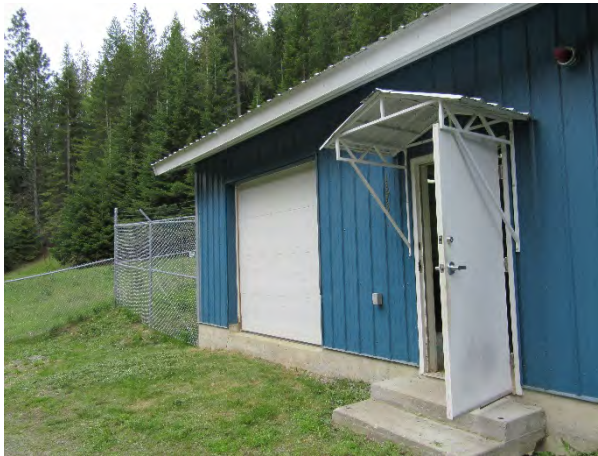
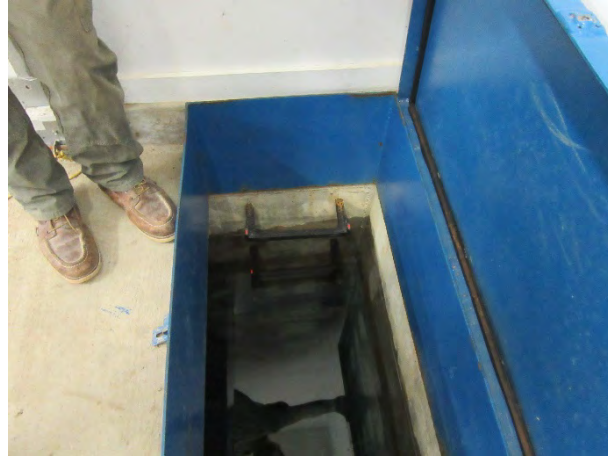
The tank was built in 1996. An interior inspection of the tank was completed in August of 2019. The inspection indicated the tank was in good condition with only minor defects. See Appendix J. Based on the majority of the system water circulating into the tank there are no issues with turnover or water age. The overflow discharges to a drainage ditch. Currently the tank could not be easily taken offline for maintenance or work without significant modifications to piping and construction of another permanent/temporary tank and booster facility. Based on the inspection and observations made by Keller Associates, the following deficiencies were identified:

- The tank is undersized and does not have enough usable volume.
- Tank pumps cavitate when tank levels are below 4 feet; the pump sumps are inadequate for the existing pumps.
- There are not options to easily take the tank offline to clean or complete maintenance work.
- There is not sufficient land on site for additional storage.
- Pump intake needs to be lower than existing tank floor elevation to fully realize existing volume.

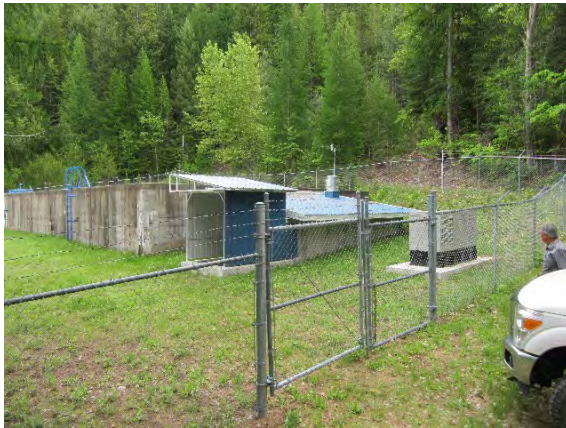
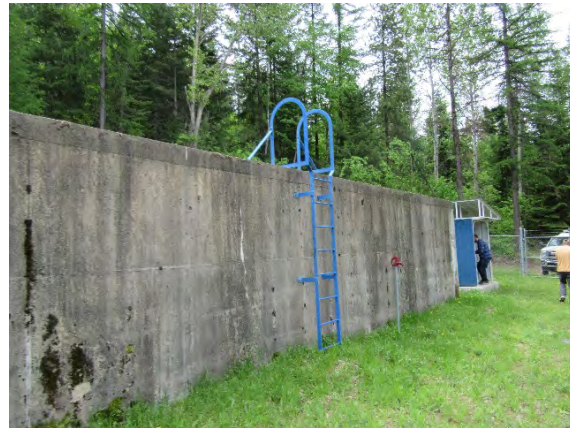
The concrete is in fair condition with one visible location of tank leaking on the exterior and isolated cracking throughout the structure. There are no internal or external coatings on the tank. Water entering the tank is currently controlled by a SCADA system, housed in the nearby booster station. Levels are monitored using an ultrasonic level detection. Currently the ultrasonic is located in the ceiling of the tank and prevents the tank from completely filling. The operator indicated that the District intends to replace the ultrasonic level detection with a pressure transducer.

In 2019, a dive inspection was conducted on the tank. See Appendix J. The inspection noted the tank was in good condition, besides some interior and exterior cracking. Based on this inspection and observations made by Keller Associates, the following deficiencies were identified:

- The concrete tank is in need of minor rehabilitation to address observed cracks.
- The facility needs intrusion alarms.
- Existing valving and controls result in excessive pressure drops during tank fills.
- Operational control updates are needed.

- Repair observed cracks to extend its useful life.
- Install intrusion alarms.
- Add a pressure sustaining valve to the tank inlet. Complete additional operating control settings to allow tank to more effectively delivery emergency and fire demands from available storage.

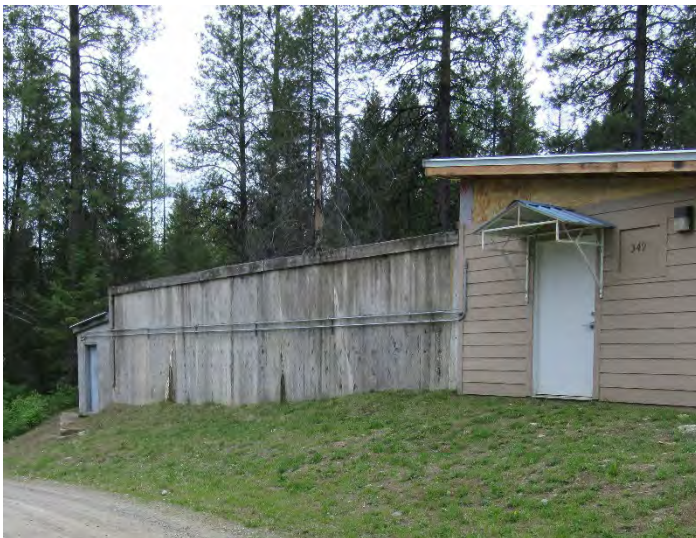
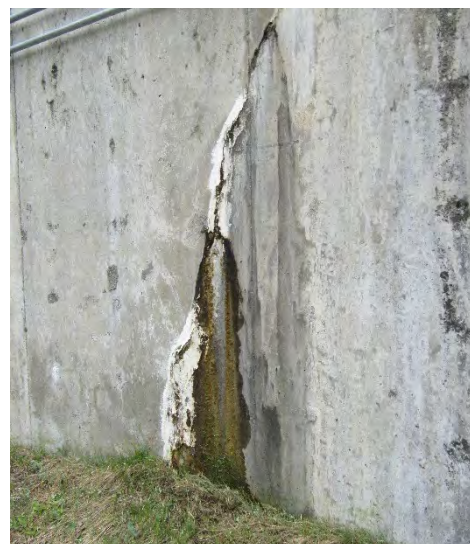
The tank inspection report from August 2019 indicated that the tank was in good condition with the exception of some bug holes, settling and cracks. See Appendix J.

- The tank concrete is starting to see wear on the exterior with cracking in isolated locations.
- The site is not secure from the public and there are no intrusion alarms.

- Repair the existing cracks further preserve the life of the concrete tank.
- Install fencing around tank and install an intrusion alarm.
- Specifically repair existing cracks that are seeping water from the tank.

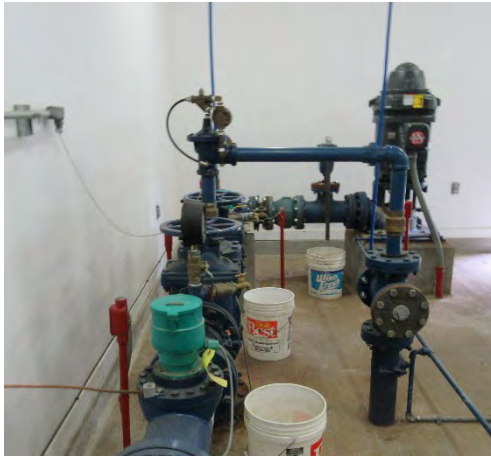
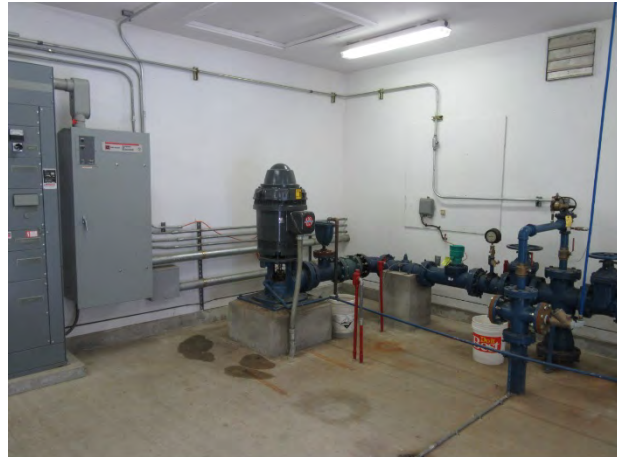
Parker Canyon Booster Station Evaluation

Deficiencies noted during the site visit include the following:

- Flow meters in poor condition.
- There corrosion on some of the valves/fittings.
- The operator reported that the generator is unreliable during emergencies (power outages).

- Replace existing flow meters.
- Replace the existing generator. Note, a larger generator will be needed to accommodate proposed pumping capacity expansions presented later in this report.

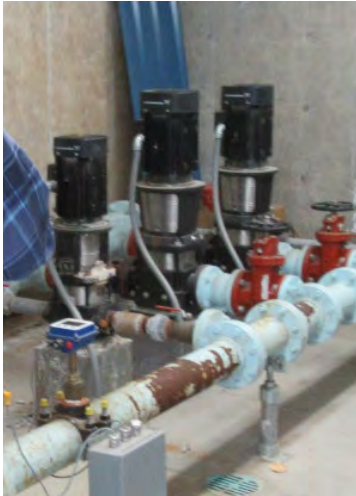
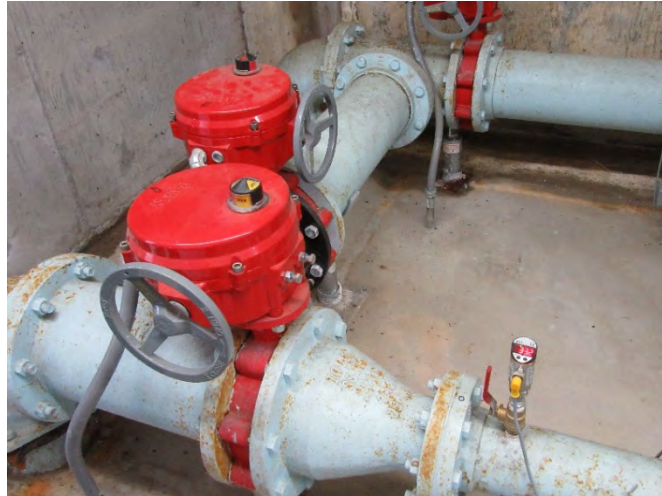
The pipe supports and valves are in fair condition. Much of the pipe coating is in poor condition with abundant rusting. There are sample taps, pressure relief provision, but no air relief provisions. The existing flow meters are old, and need to be replaced. There is a generator on site that provides single phase power (converted to 3 phase for the pumps) that is in fair condition.

- The booster station cannot operate when the pump is filling.
- Flow meter has reached its useful life.
- Pump 1 is used almost constantly and needs replacement.
- Pipe coating is in poor condition.

- Replace Pump 1.
- Install new flow meter.
- Install air relief measures.
- Recoat exposed piping.

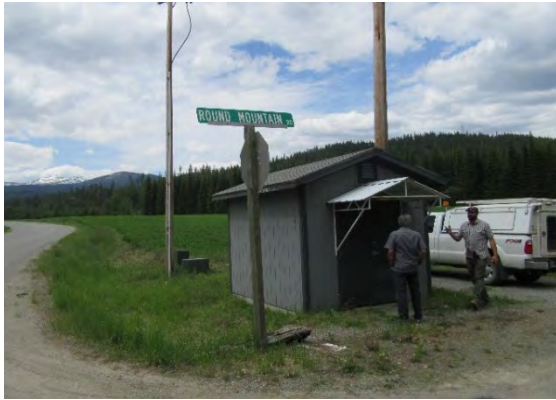
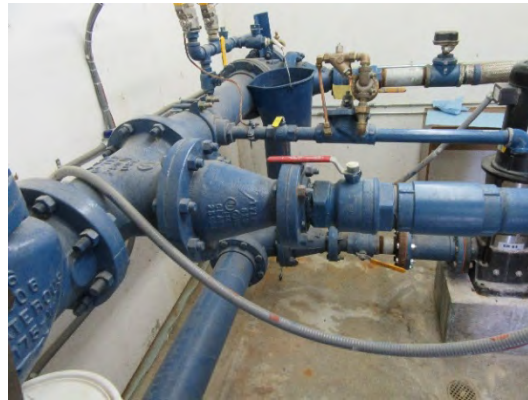
The pumps in the booster station are 10-hp and 7.5-hp VFDs with the 10-hp being an agricultural irrigation pump that is in poor condition; these two pumps operate in rotation, switching daily at 8 AM, however, both can run at the same time if demand requires. The 7.5-hp pump was replaced in 2009 but the operator has noted operation and maintenance issues with upkeep of this pump. Currently, the 7.5-hp pump operates at 61 feet of total dynamic head. There is no backup generator onsite. There is pressure relief available, but no air relief provisions within the house piping. The valves are in fair condition and the existing flow meter (paddle style) should be replaced with a magnetic flow meter. New pressure transducers are needed. Multiple segments and connections of piping were not plumbed vertically, straight horizontally or had appropriate support, which could result in leaking and issues in the future.

- Given the large number of deficiencies and overall age of the booster facility, plus the need for upgrades triggered by desired increased pressures and future flow conditions, we recommend replacing the booster station with a completely new booster station and building. In order to complete this improvement, an additional easement or property purchase is recommended.

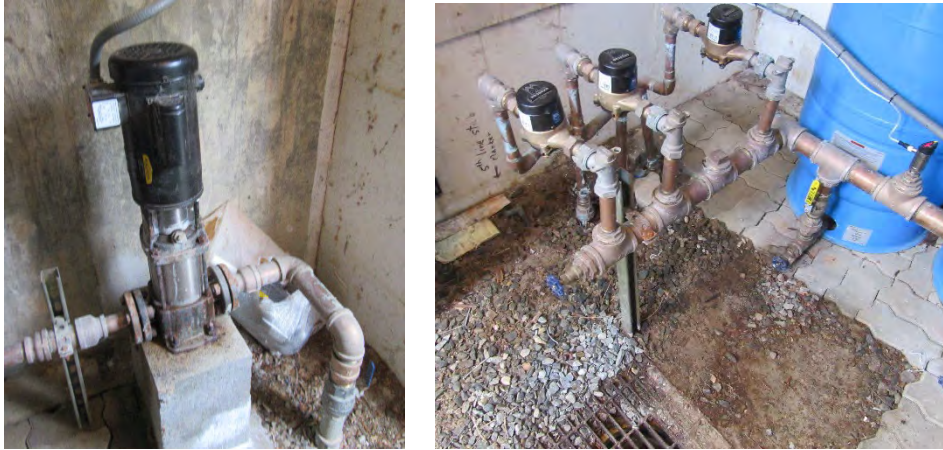
The booster station consists of a single pump (in fair condition) pump operates on single phase power and appear to be in poor condition. Pipe supports and valving are also in fair condition. There are no pressure relief or air relief valves. The water meters are currently located in the booster station (three).

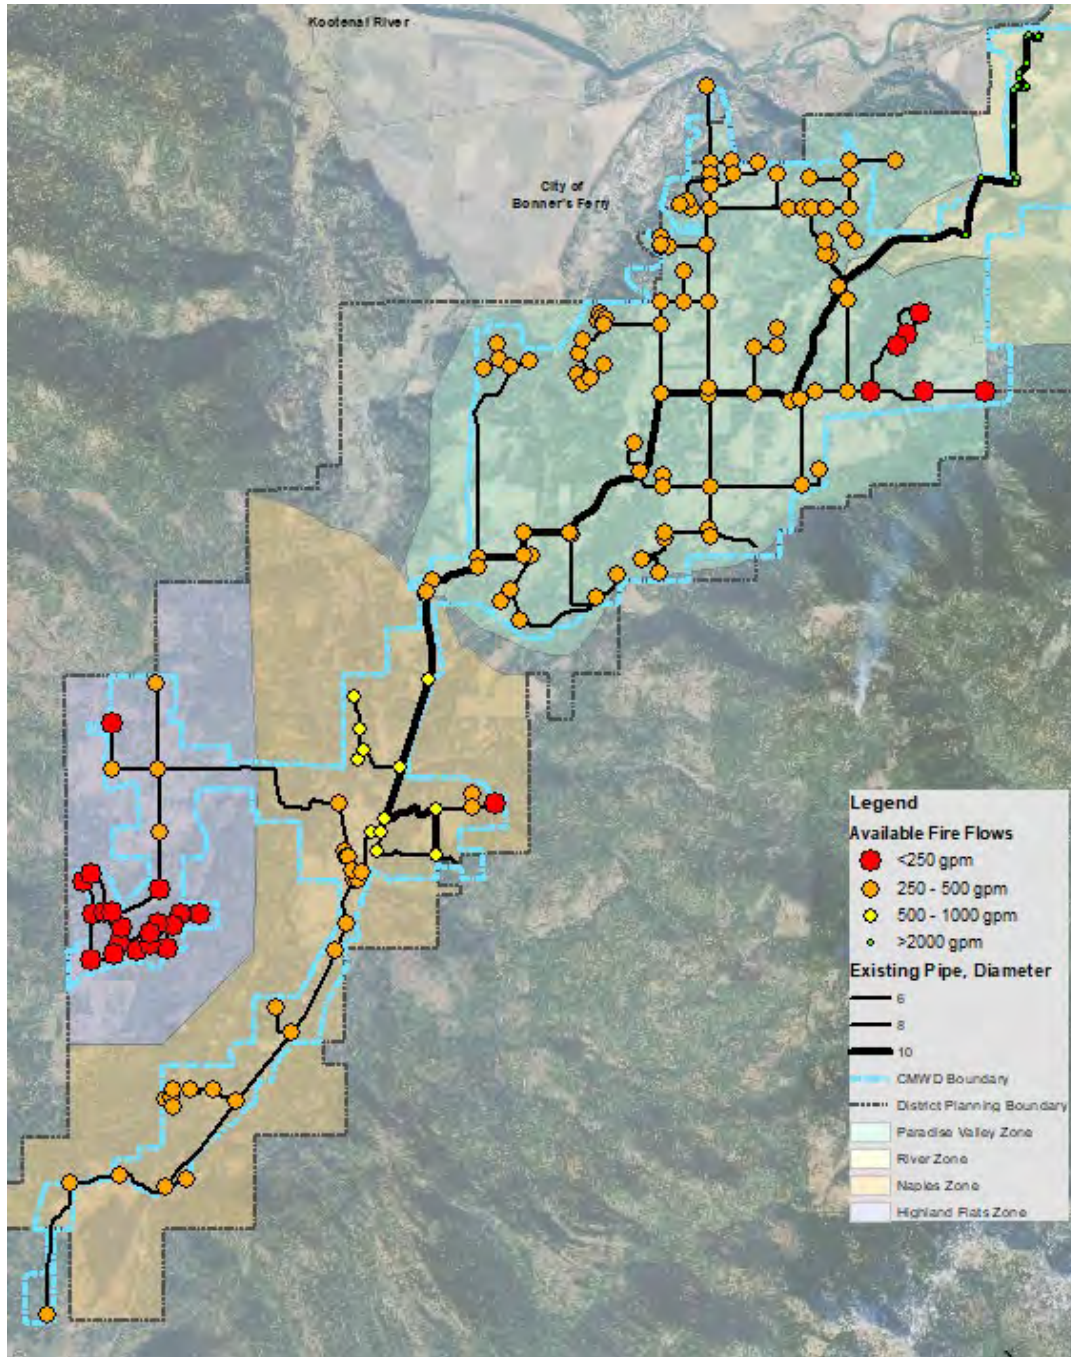
Figure 2.2: Available Fire Flows Under Max Day Demands (Existing System)

Areas of inadequate fire protection include the east Paradise Zone along Kootenai Trail Rd, in the Naples Zone along Mountain Meadows Rd, and in the extremities and southern portion of the Highlands Zone. The inadequate available fire flow in these areas is primarily a result of undersized lines, inadequate delivery capacity (ie transmission piping and pumping), and lack of system looping. In addition, most of the system experiences less than 500 gpm of available fire flow.

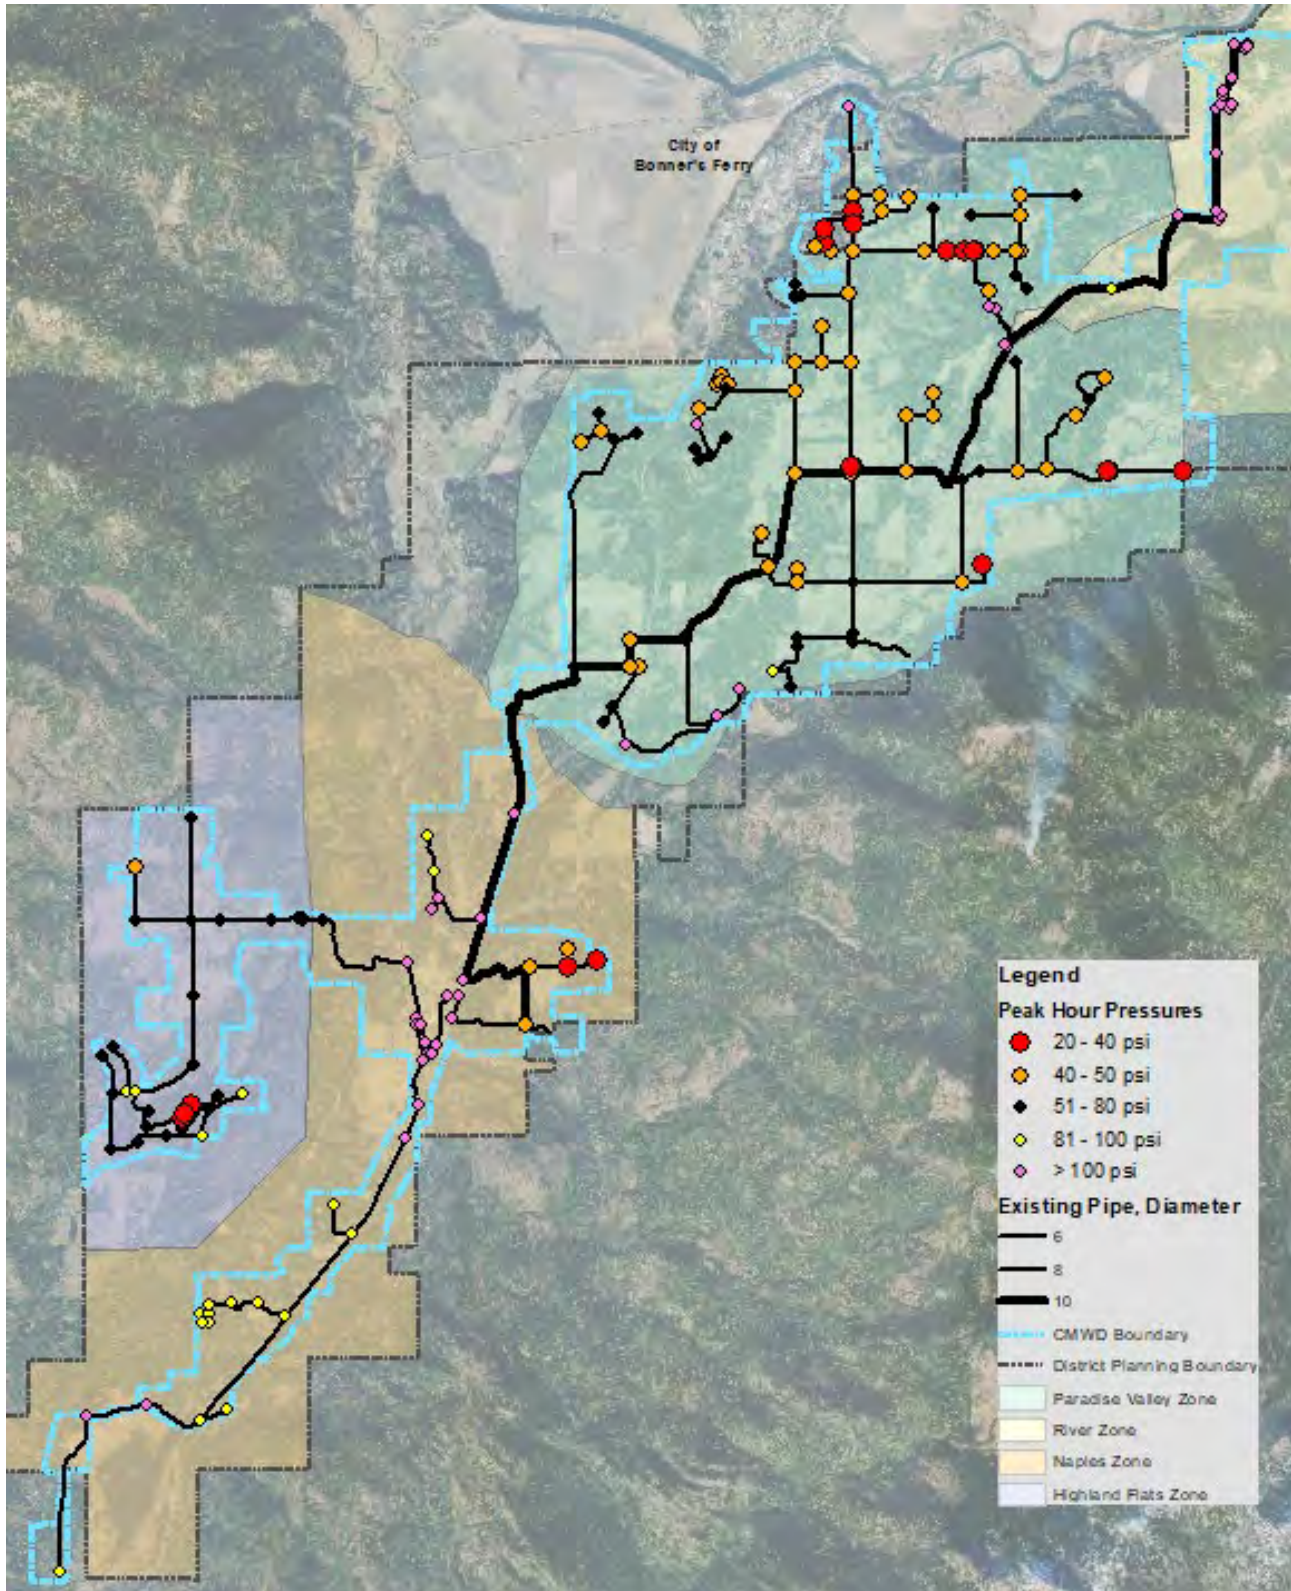
Figure 2.3: Existing System Pressures Under Peak Hour Demands

As shown, several areas do not meet the minimum 40 psi requirement for peak hour demand conditions. Several of these areas are overlap with the inadequate available fire flow areas presented previously. Additionally, much of the north portion of the Paradise Valley zone experiences less than 50 psi.

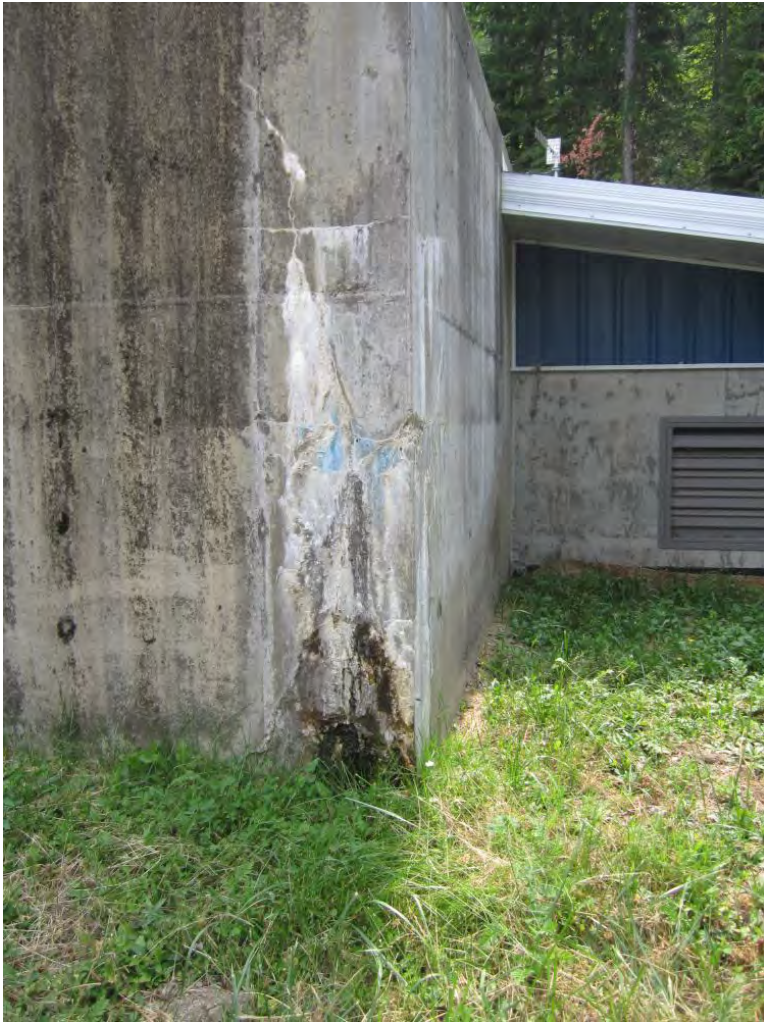
Photograph 49: Black Mountain reservoir (leak)

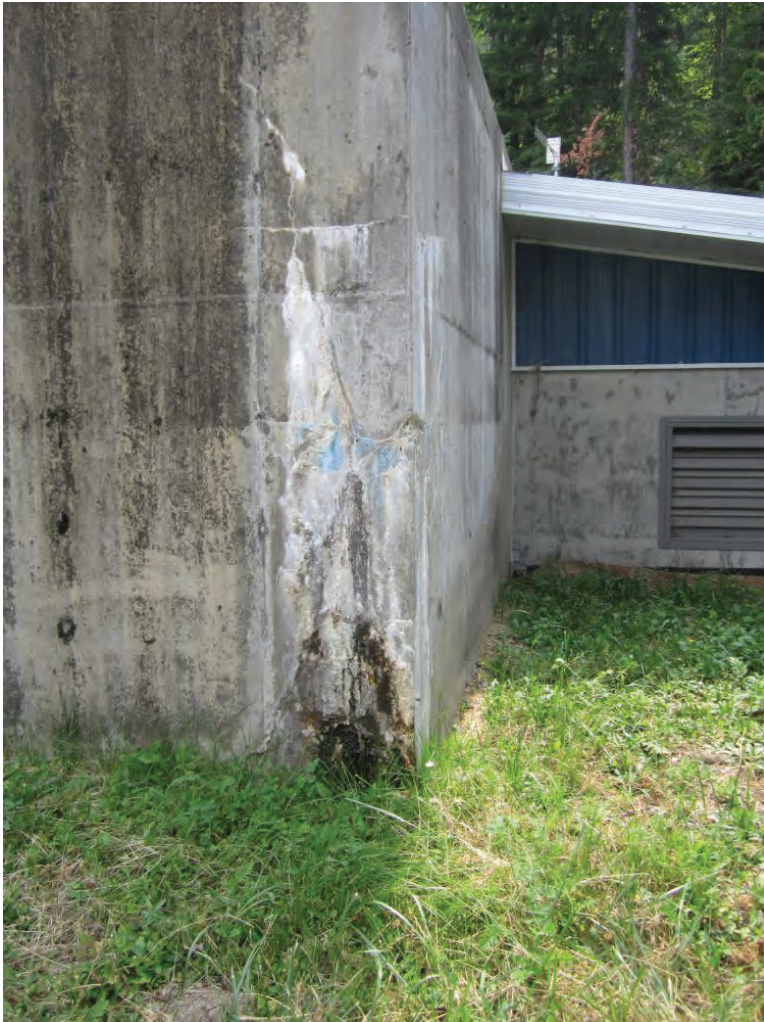
Photograph 49: Black Mountain reservoir (leak)
