CABINET MOUNTAINS WATER DISTRICT

WATER SYSTEM FACILITY PLAN UPDATE

APRIL 2020

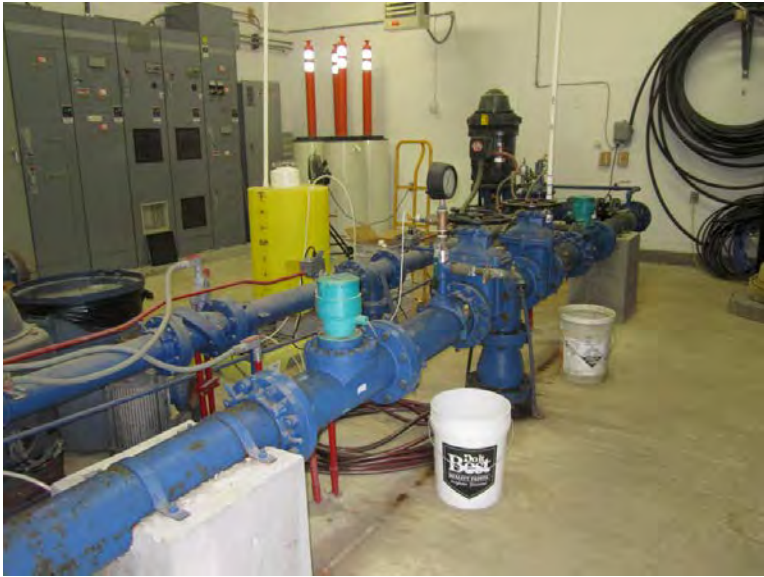
Photograph 1: Well discharge appurtenances

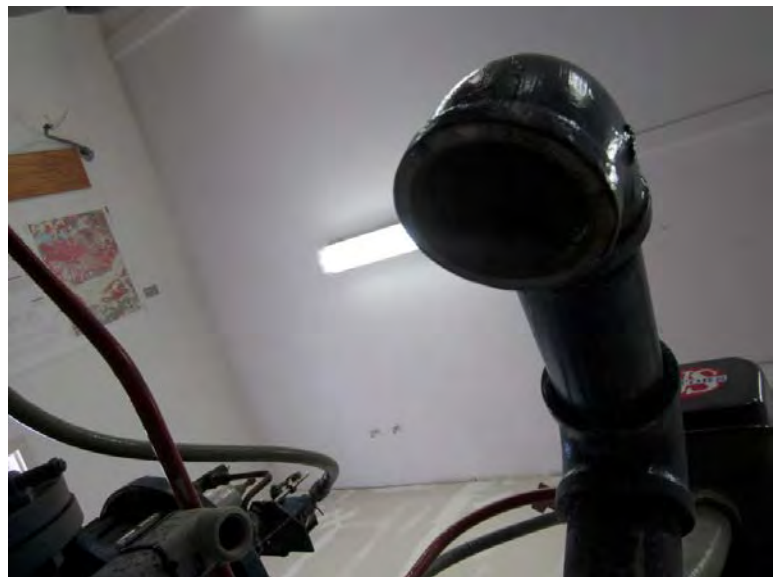
Photograph 4: Well 1 screened vent

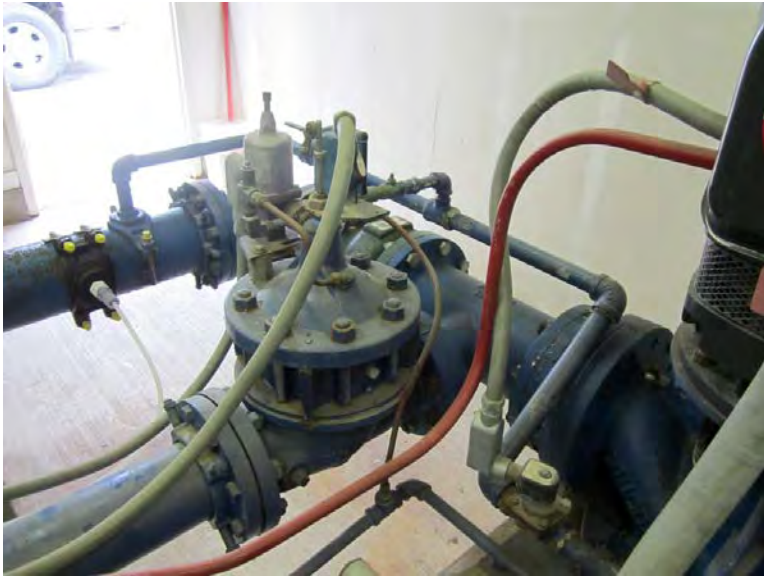
Photograph 5: Well 1 discharge to waste control valve

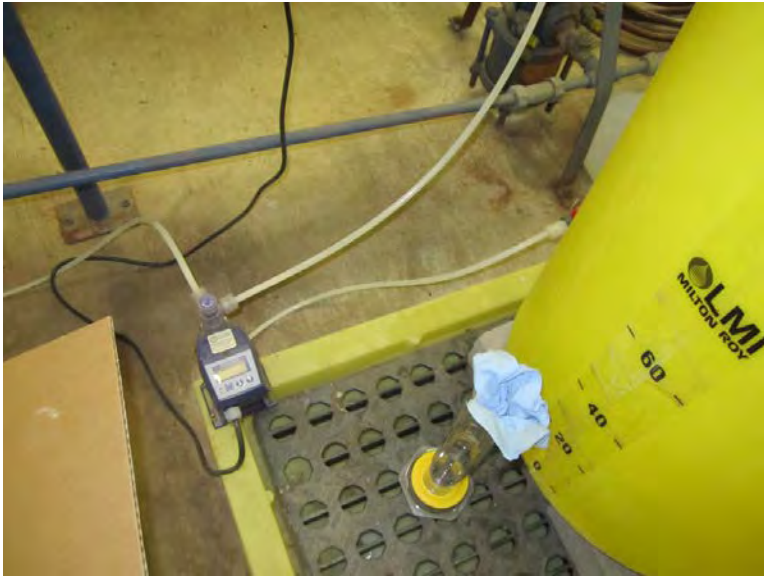
Photograph 9: Well 2 electronic metering pump and calibration cylinder

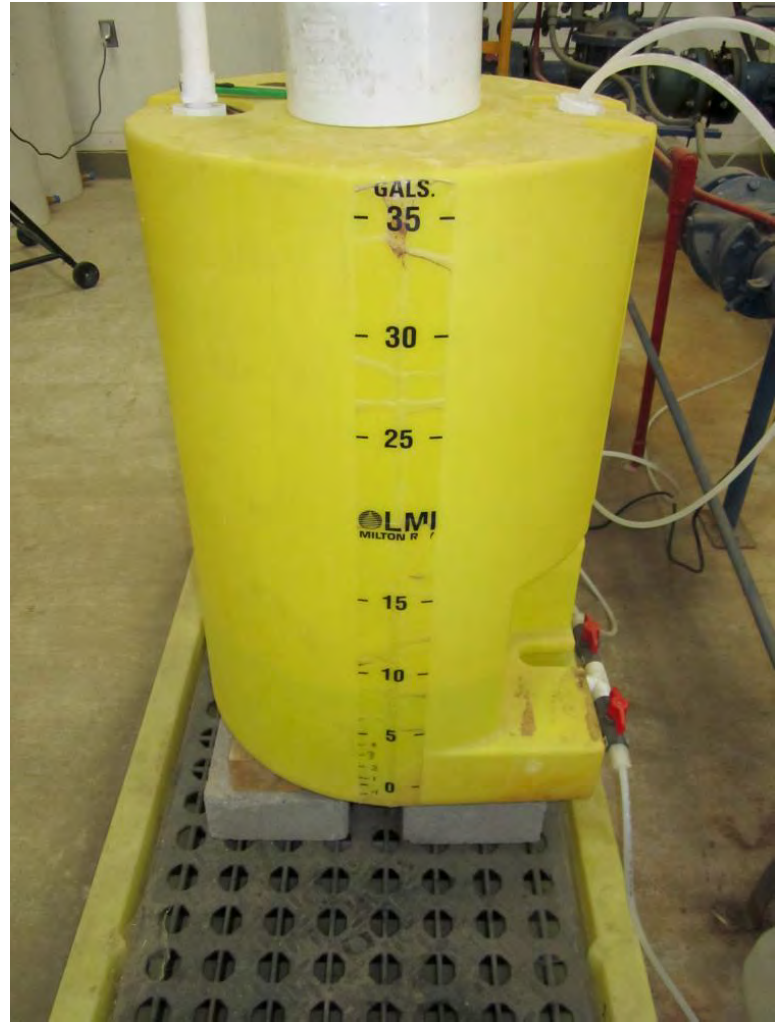
Photograph 10: Sodium hypochlorite day tank

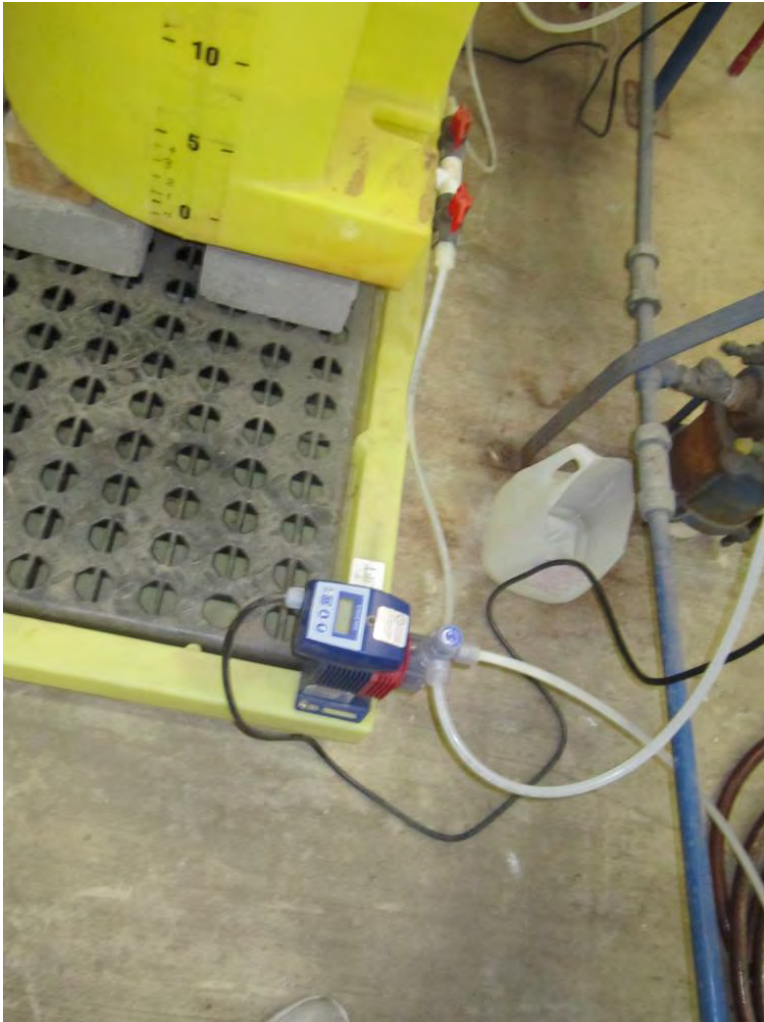
Photograph 11: Well 1 electronic metering pump

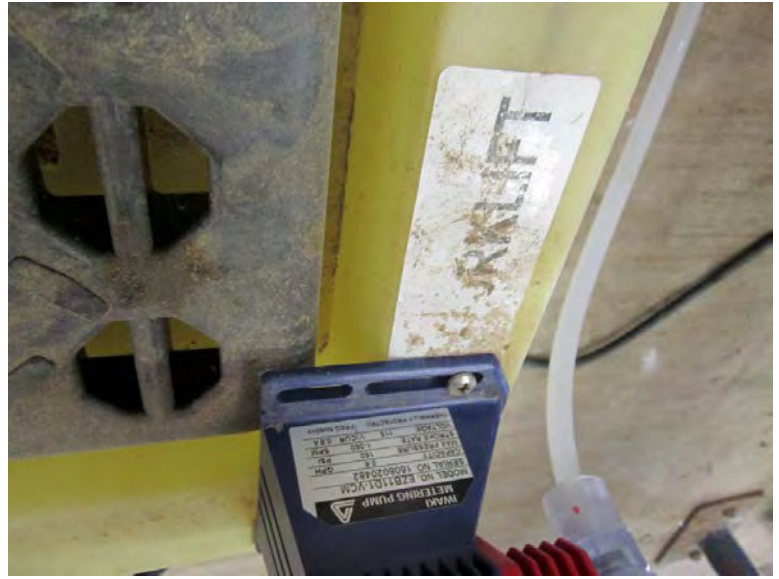
Photograph 12: Electronic metering pump placard

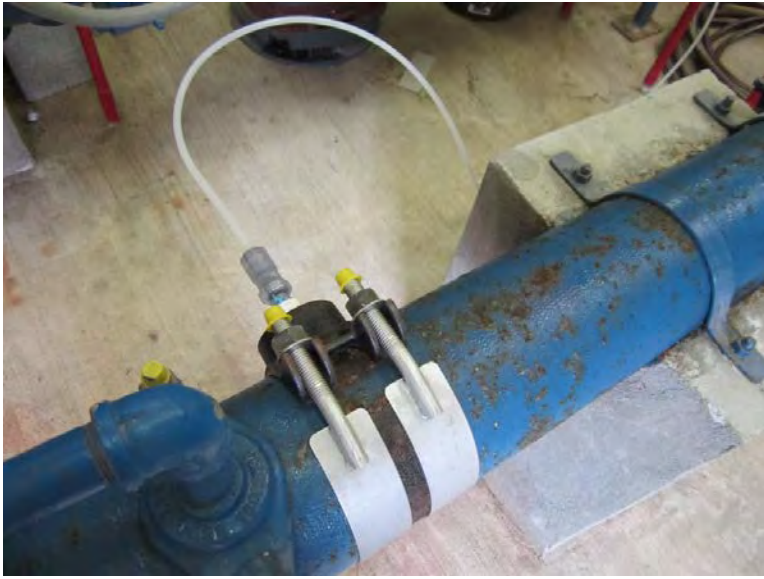
Photograph 13: Sodium hypochlorite injection quill

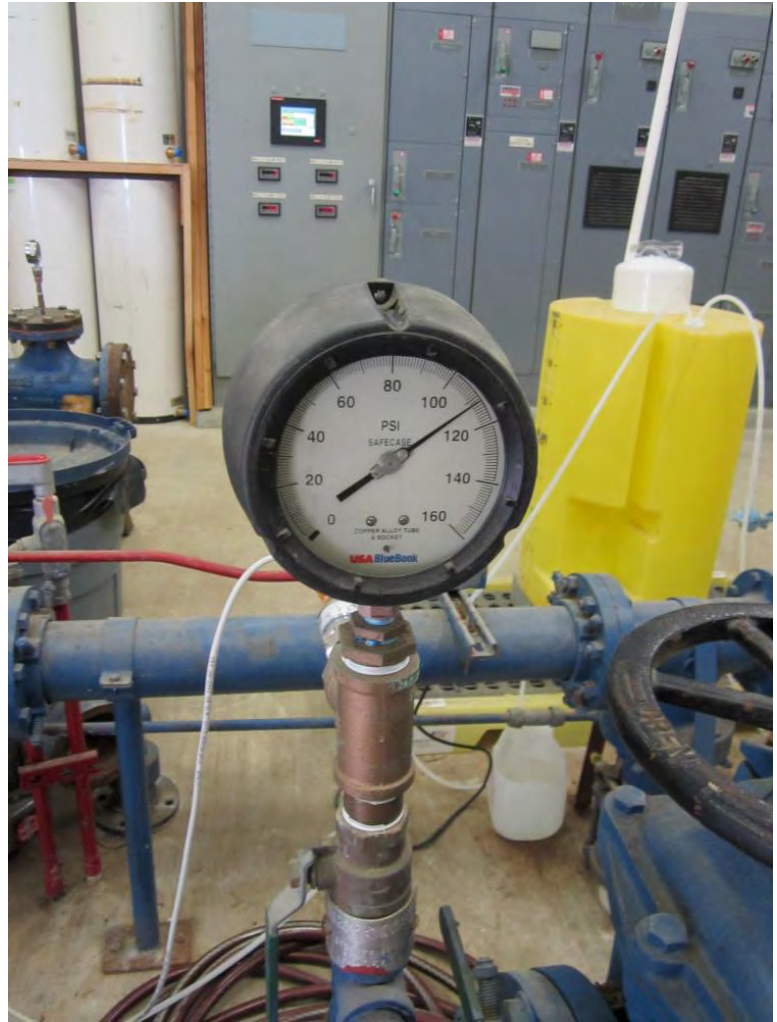
Photograph 14: Pressure gage well discharge

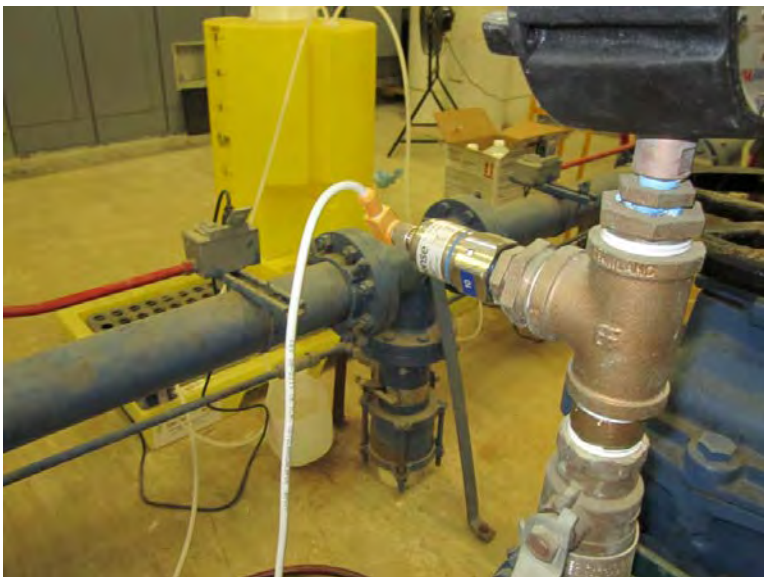
Photograph 15: Pressure transducer on combined well discharge

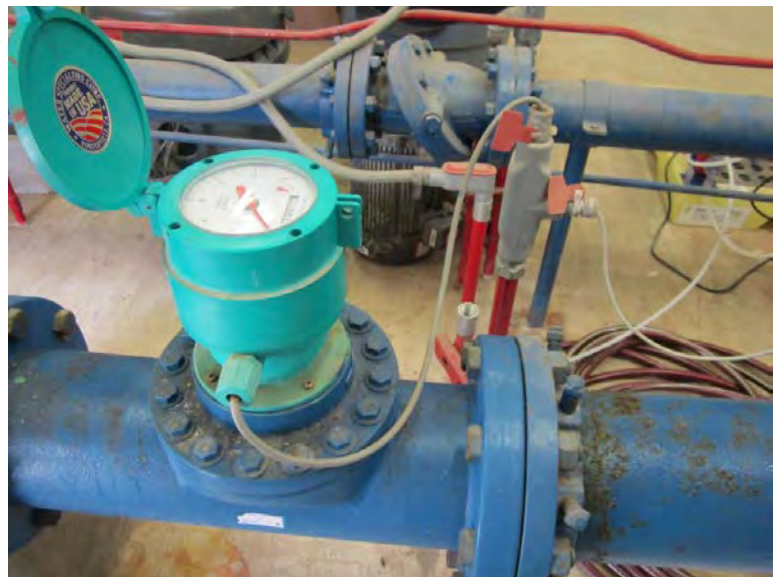
Photograph 16: Individual flow meter tied to electronic chlorine metering pump

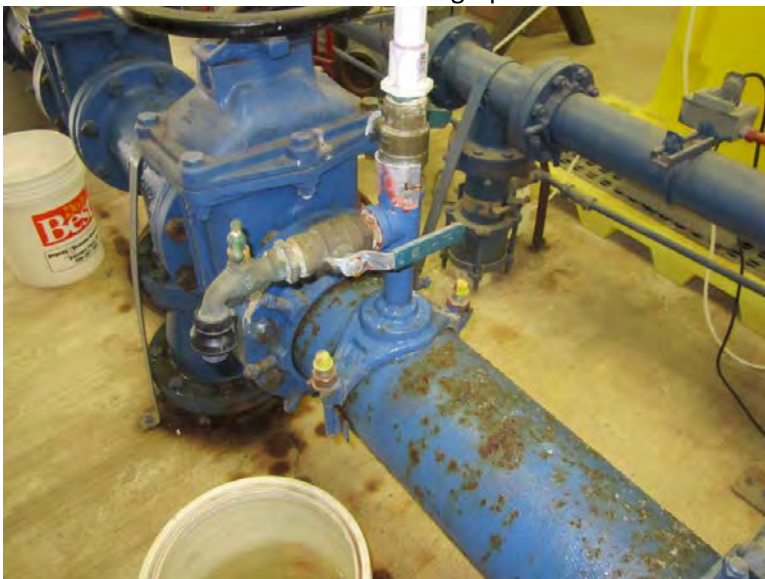
Photograph 17: Finished (chlorinated) sample tap

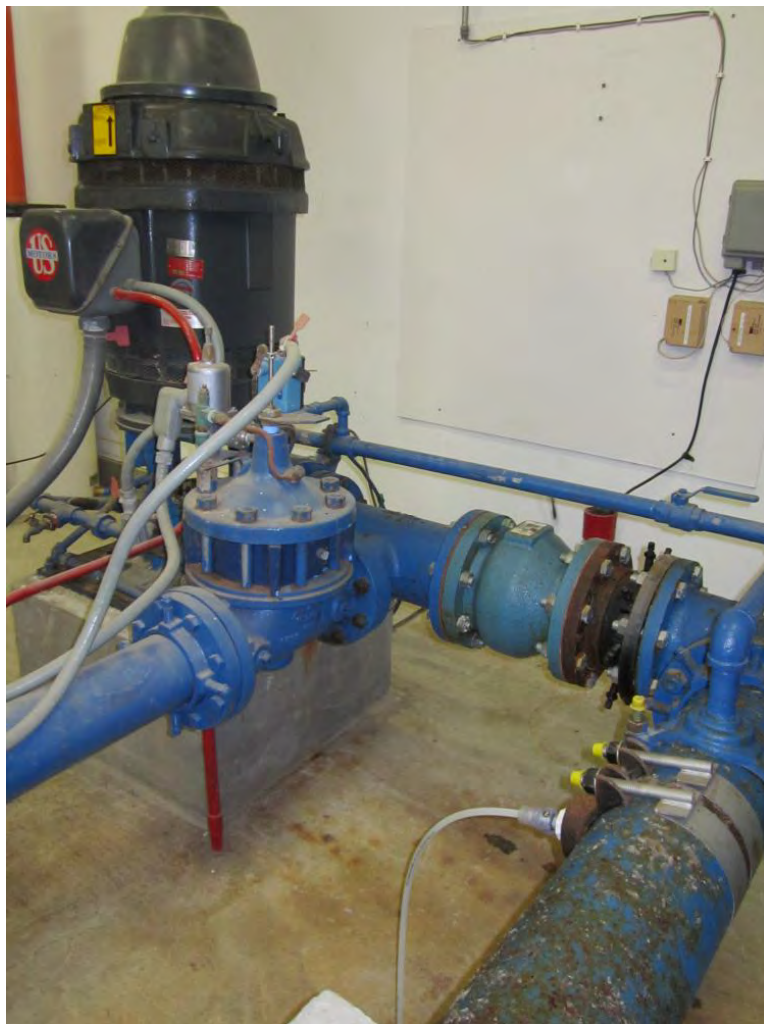
Photograph 18: Well 2 discharge to waste control valve

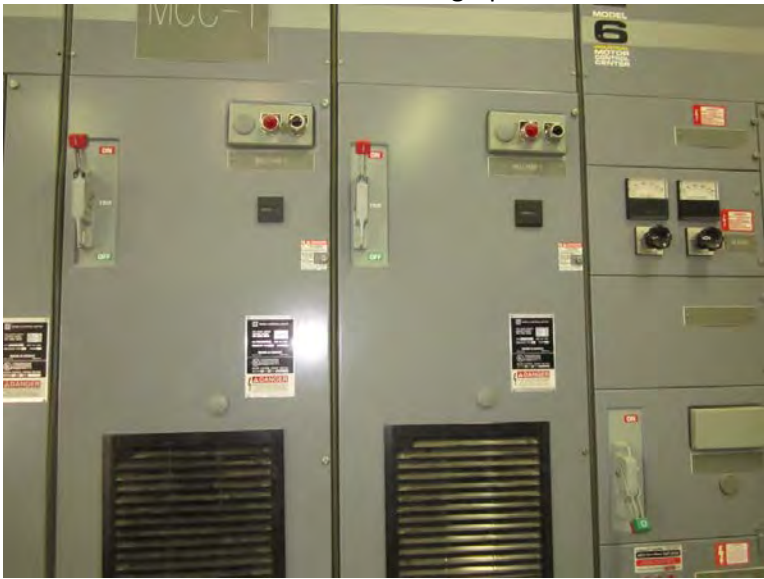
Photograph 19: Well electrical switches

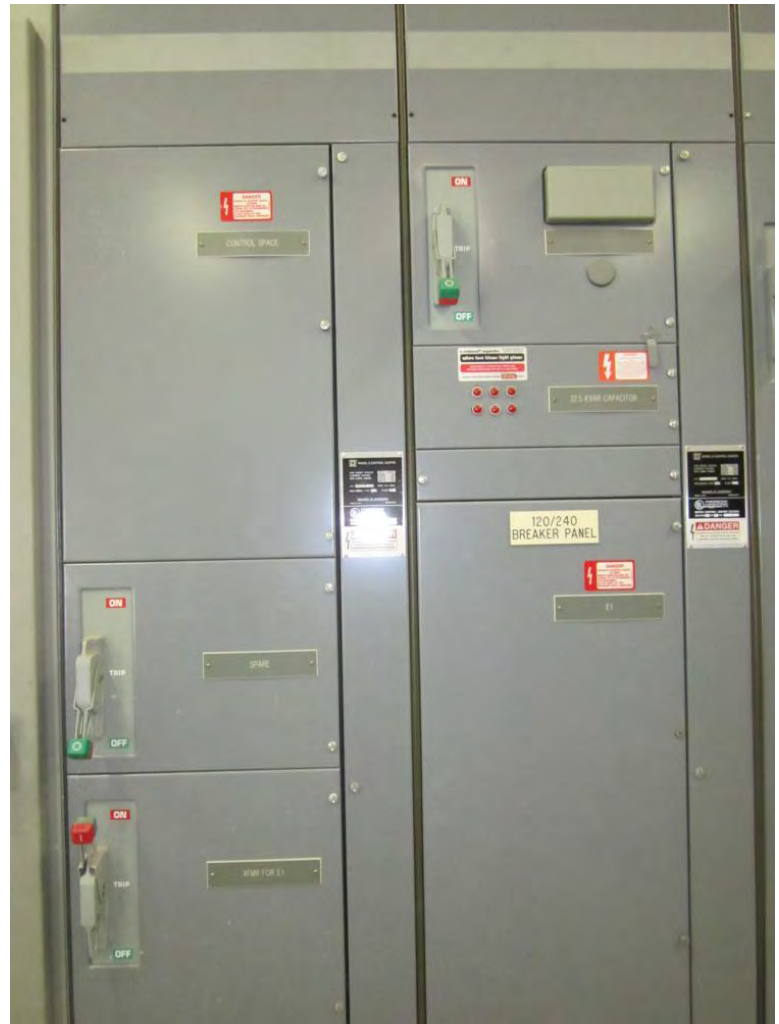
Photograph 20: Well electrical switches

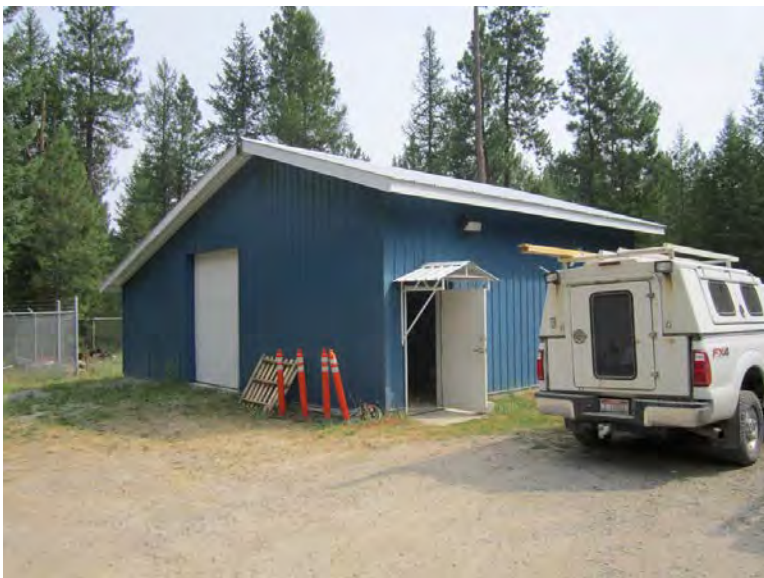
Photograph 23: Well 1 and 2 building

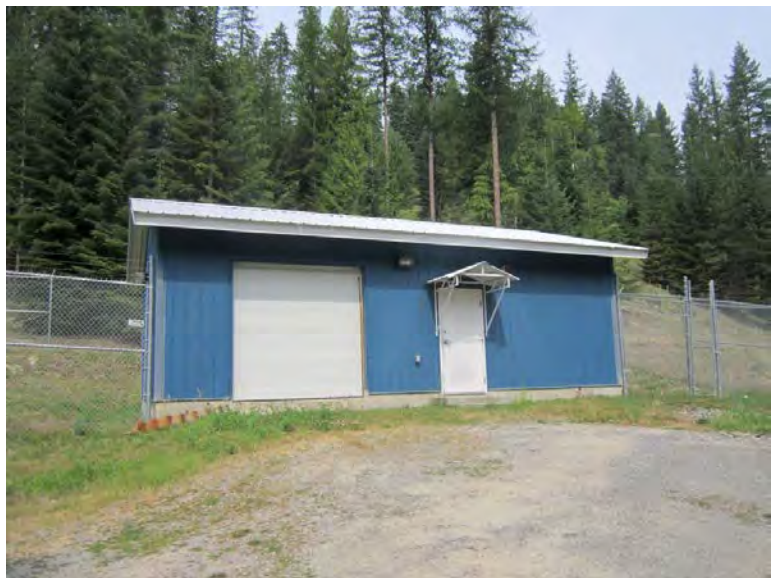
Photograph 24: Parker Canyon booster station

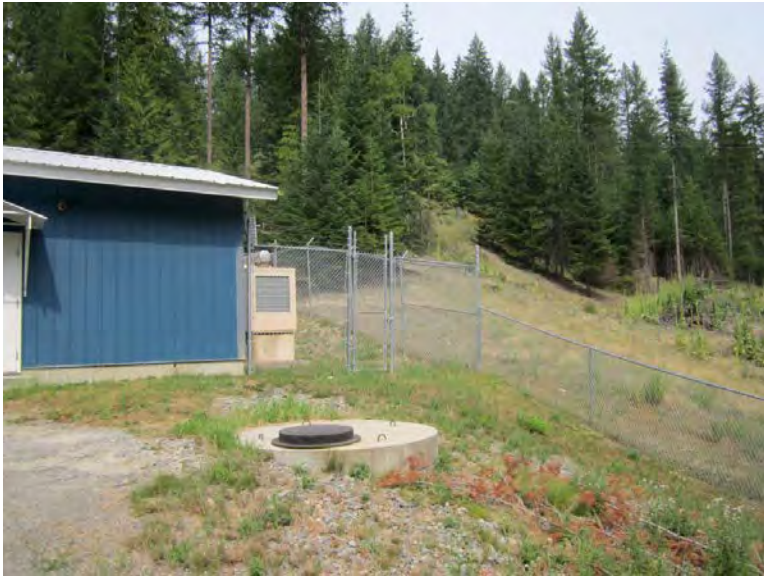
Photograph 25: Parker Canyon diesel generator

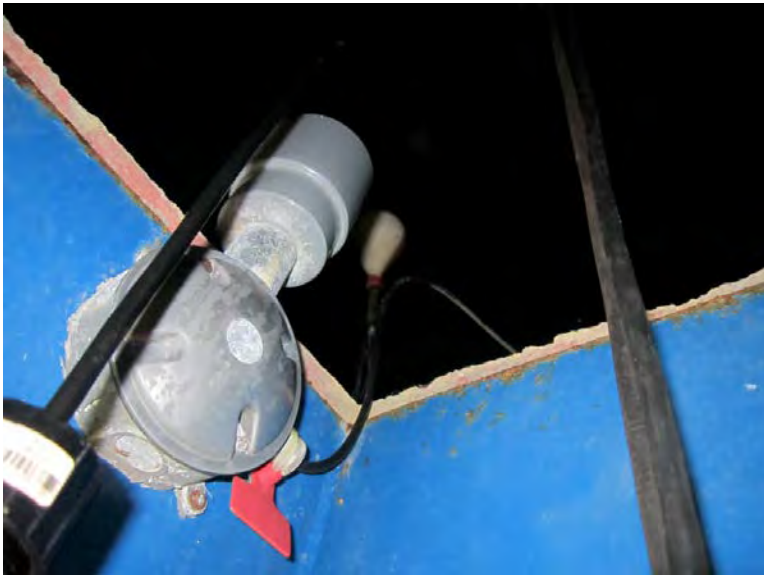
Photograph 27: Parker Canyon level controls (well actuation)

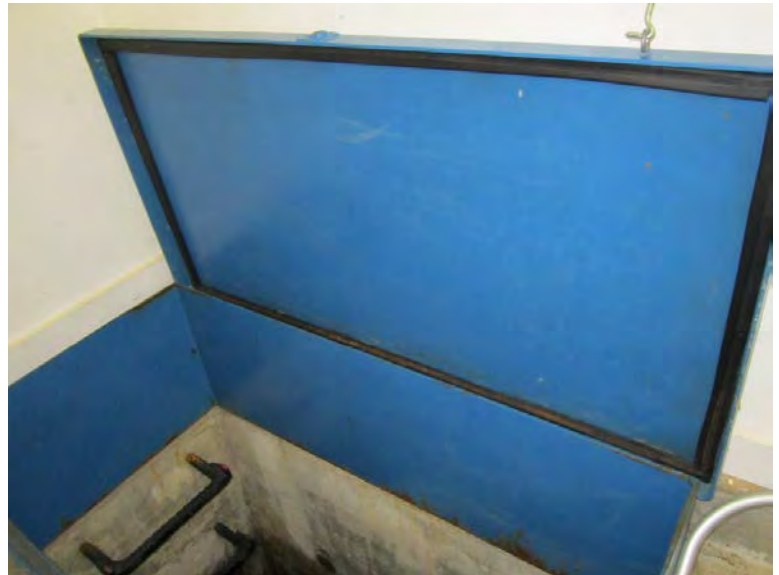
Photograph 28: Parker Canyon tank water tight access hatch

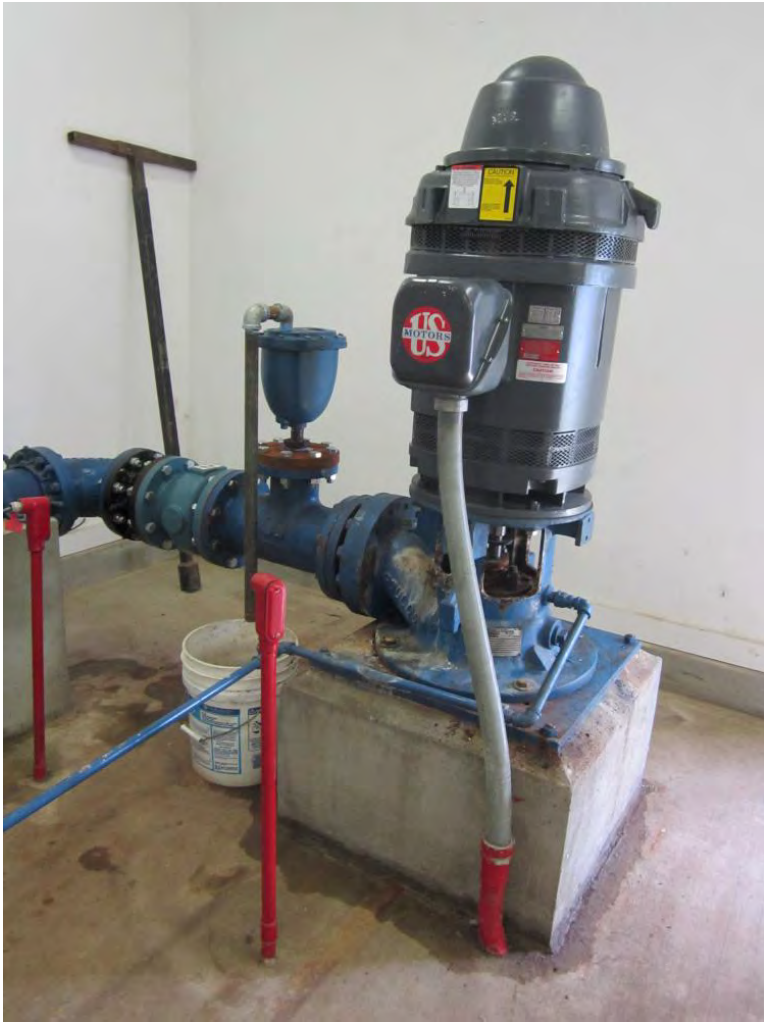
Photograph 29: Parker Canyon booster pump

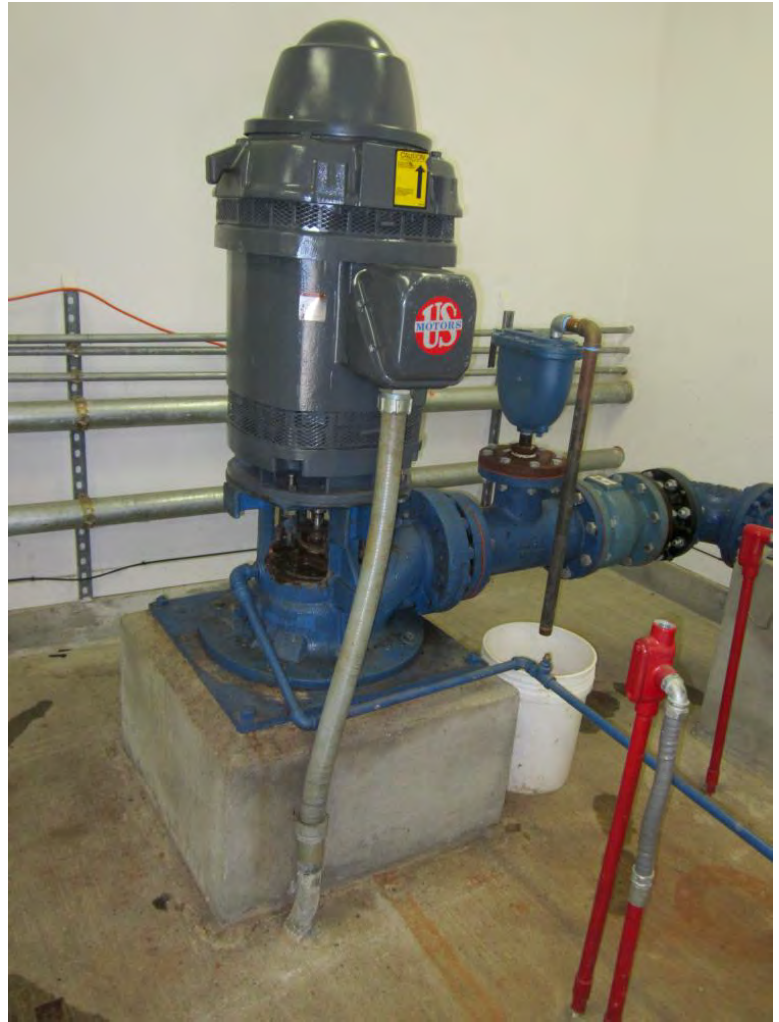
Photograph 30: Parker Canyon booster pump

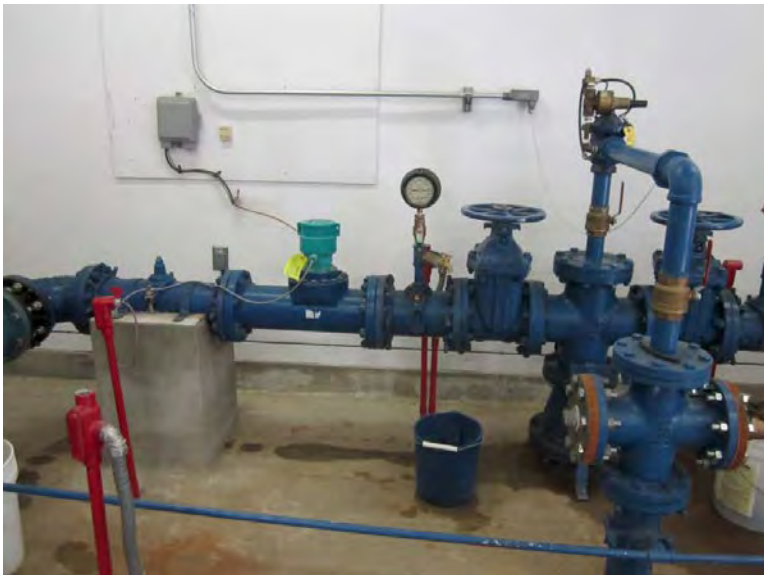
Photograph 31: Parker Canyon boosted discharge appurtenances

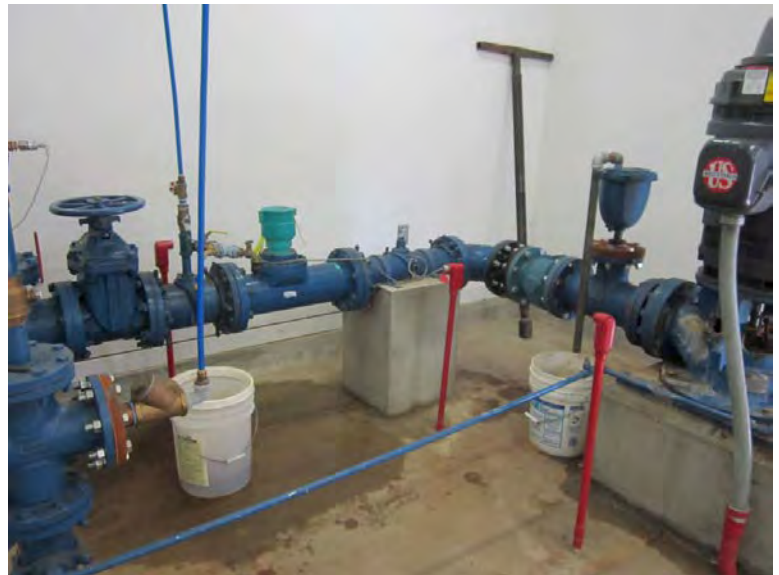
Photograph 32: Parker Canyon boosted discharge appurtenances

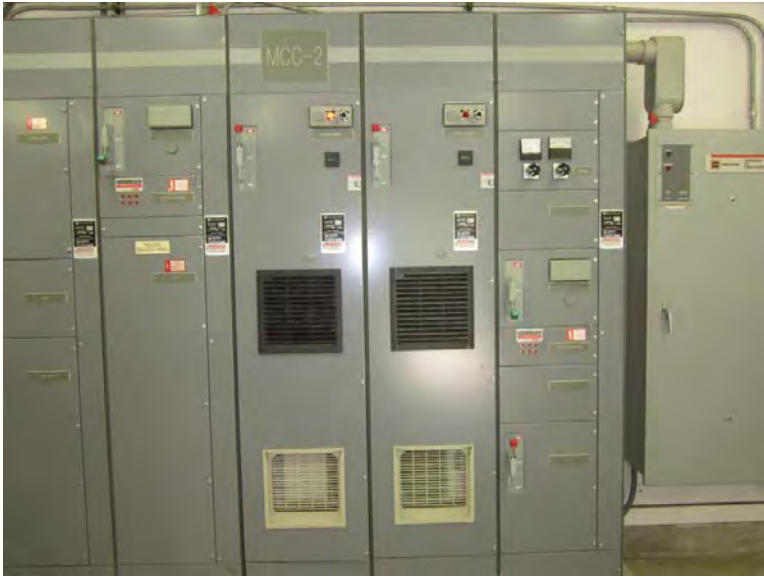
Photograph 33: Parker Canyon booster pump controls

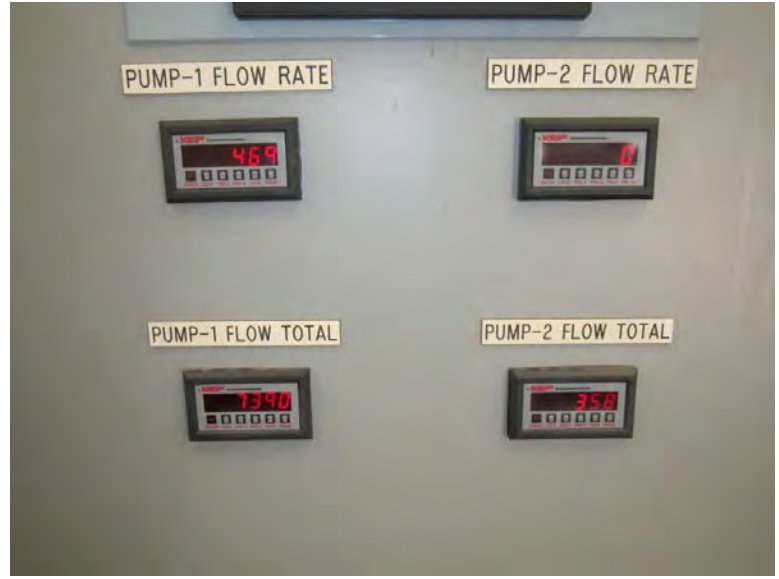
Photograph 34: Parker Canyon pump controls

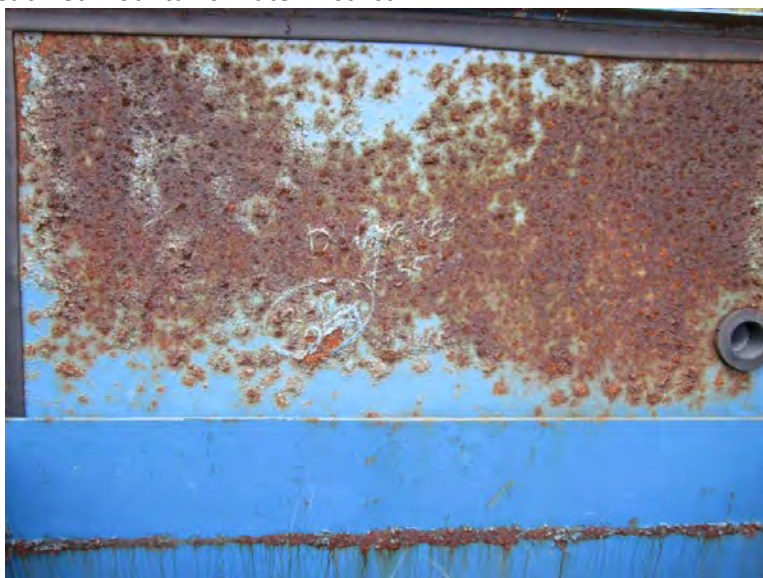
Photograph 86: Naples tank lid w water tight seal

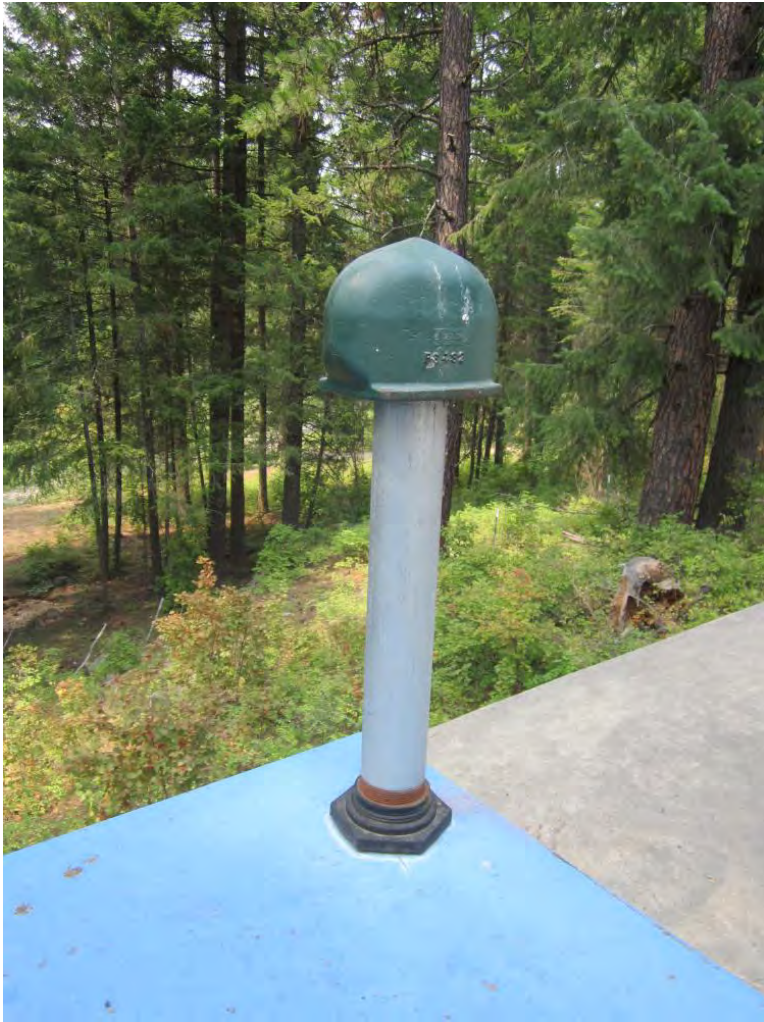
Photograph 87: Naples tank lid w screened vent

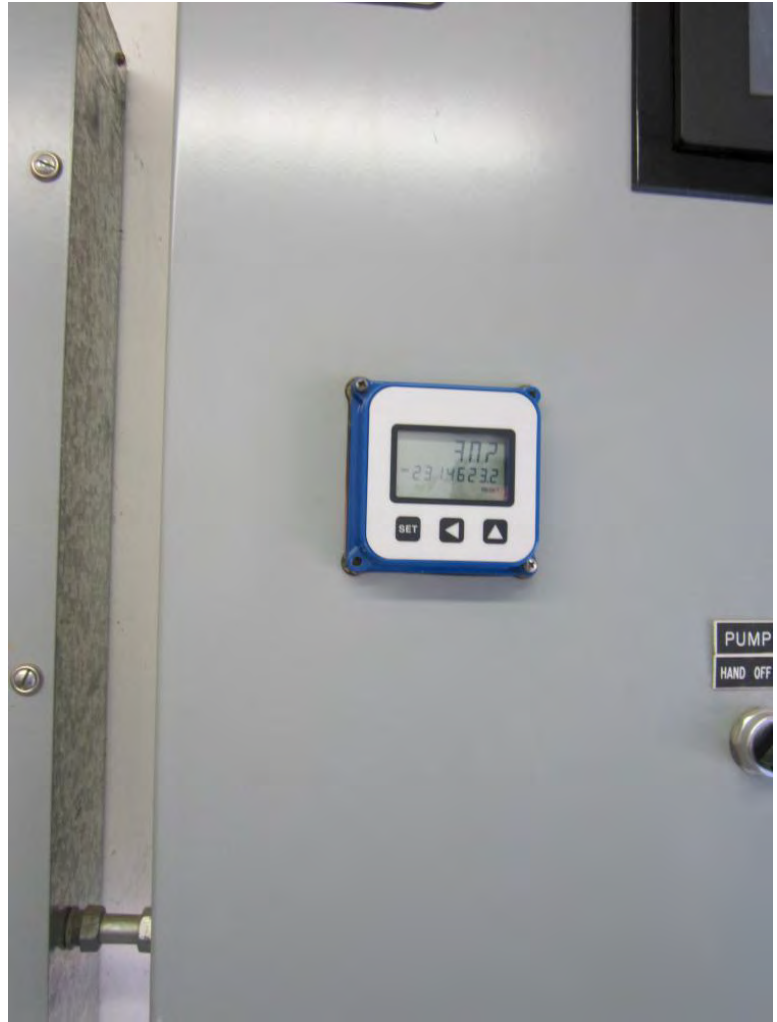
Photograph 92: Highland Flats flow meter (malfunctioning)

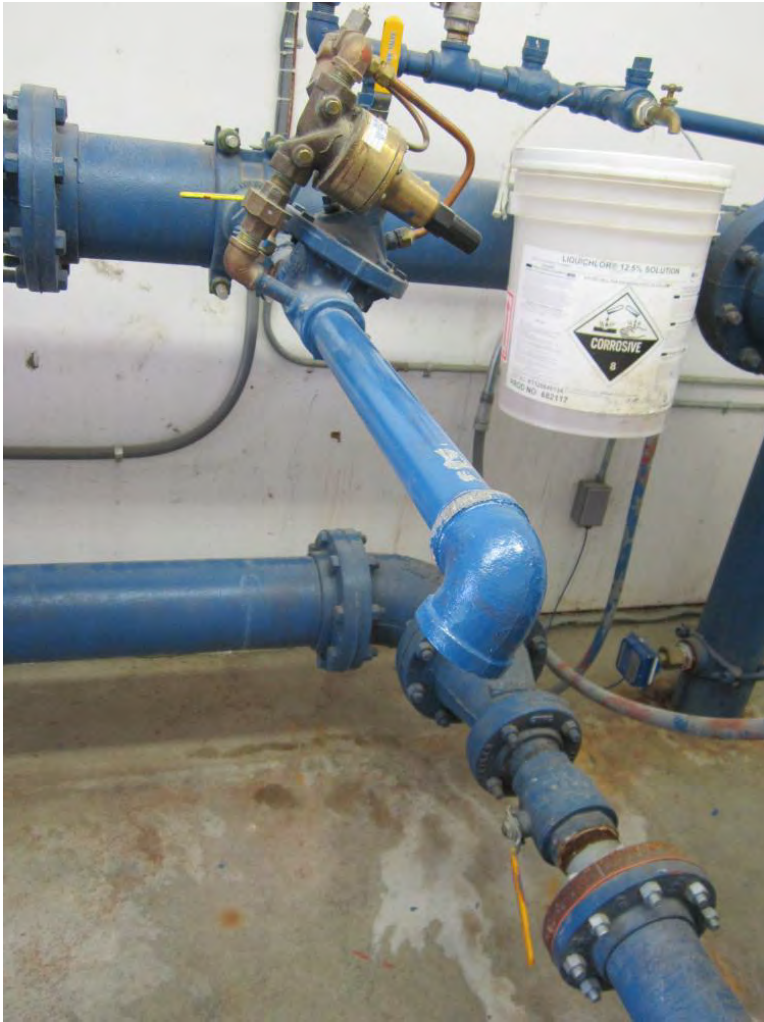
Photograph 93: Highland Flats pressure relief (requires reconfiguration of discharge)

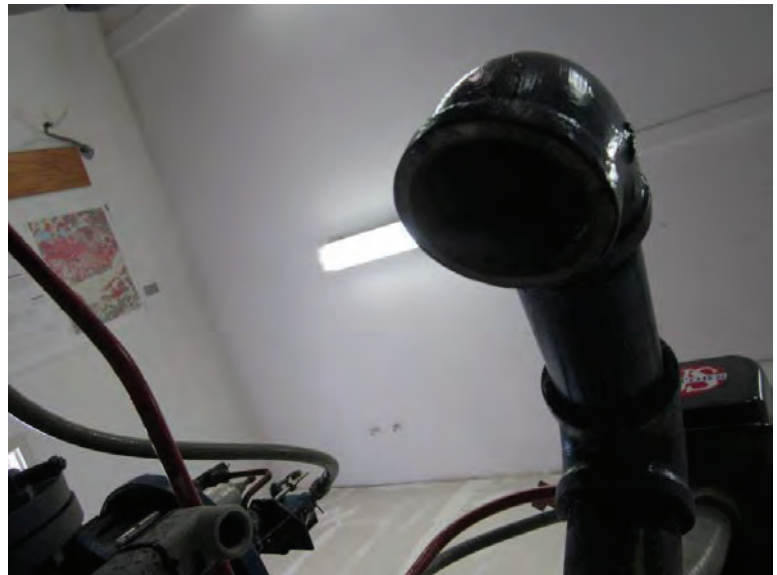
Photograph 4: Well 1 screened vent

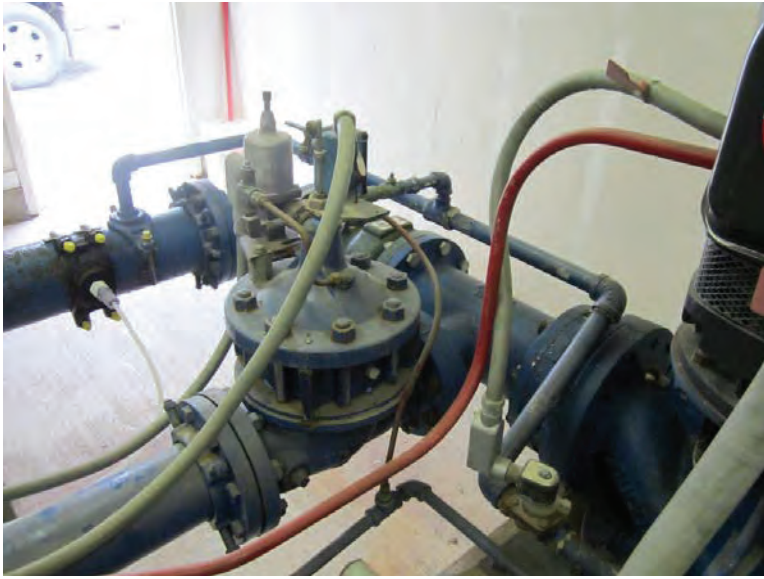
Photograph 5: Well 1 discharge to waste control valve

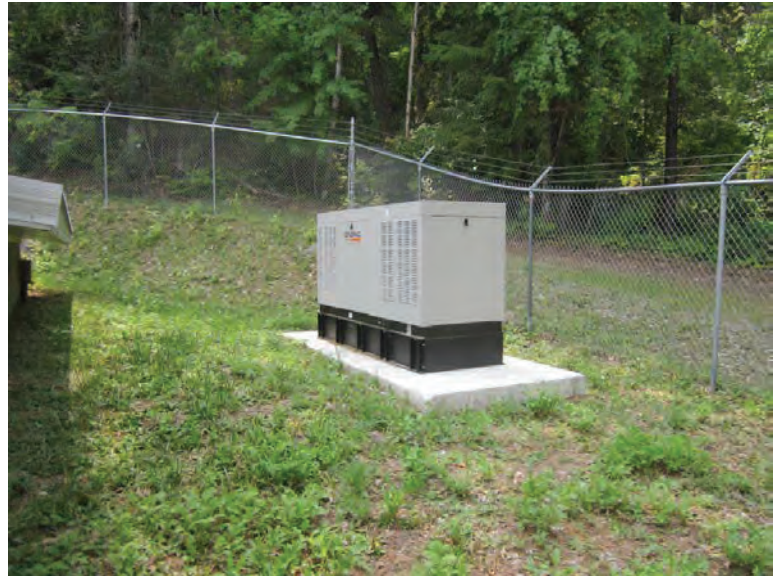
Photograph 58: Black Mountain booster station diesel generator

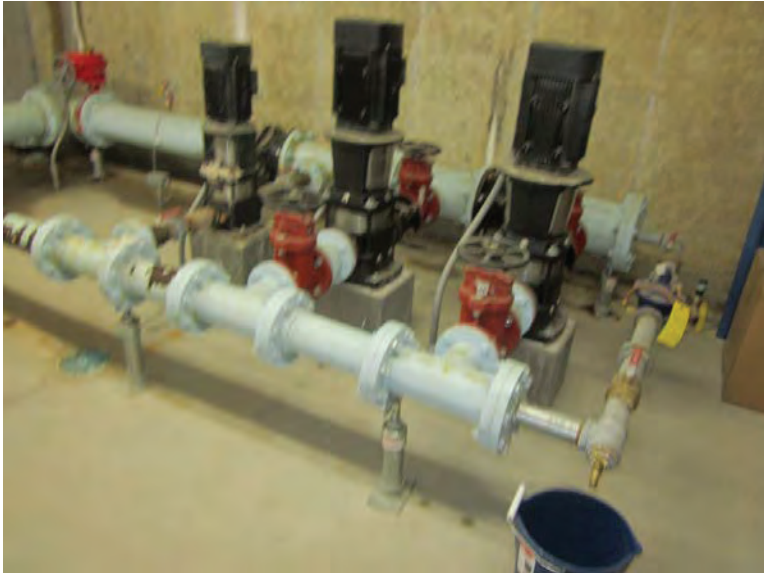
Photograph 59: Black Mountain booster pumps and discharge appurtenances

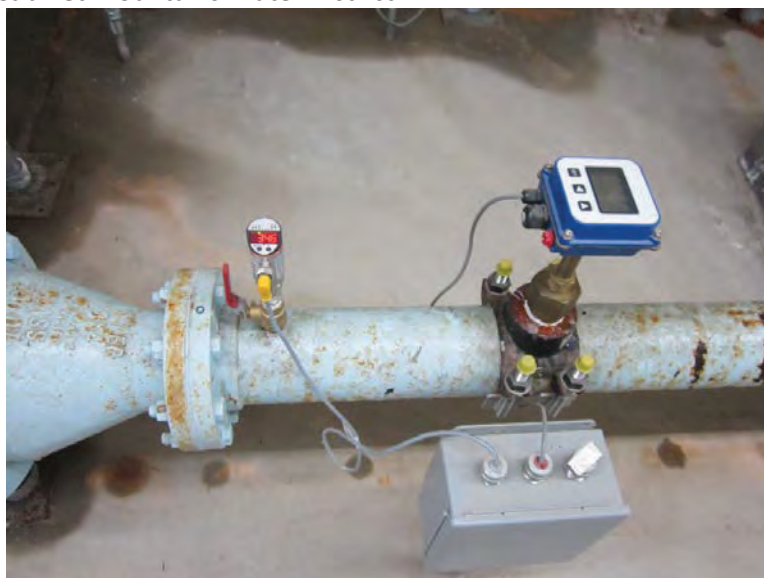
Photograph 62: Black Mountain boosted discharge flow meter

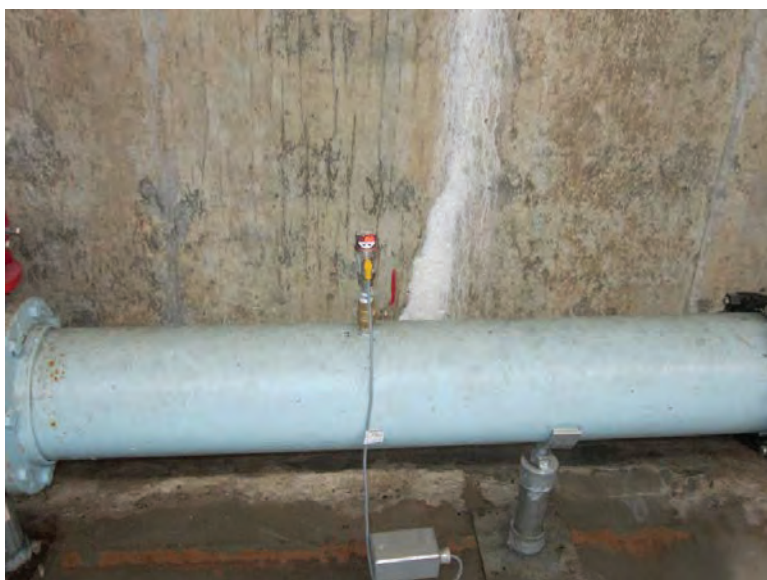
Photograph 63: Black Mountain boosted discharge appurtenances flow meter

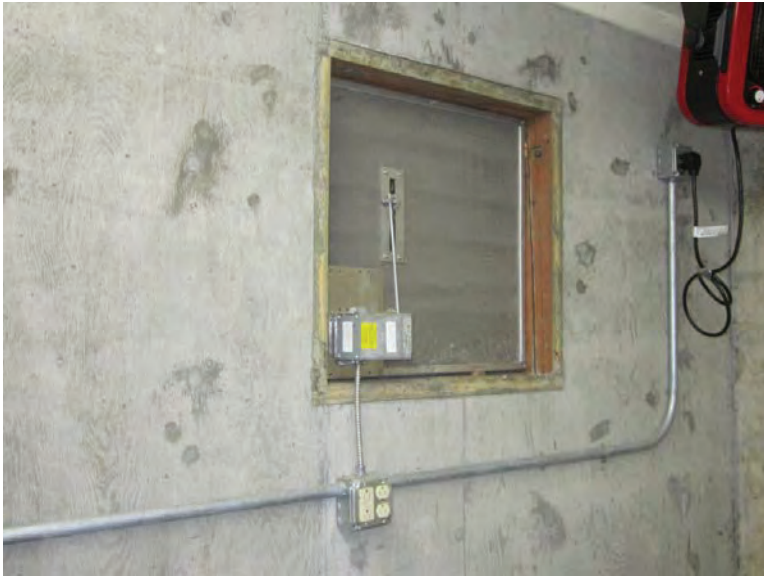
Photograph 65: Black Mountain booster station, thermostatically controlled louvre vent

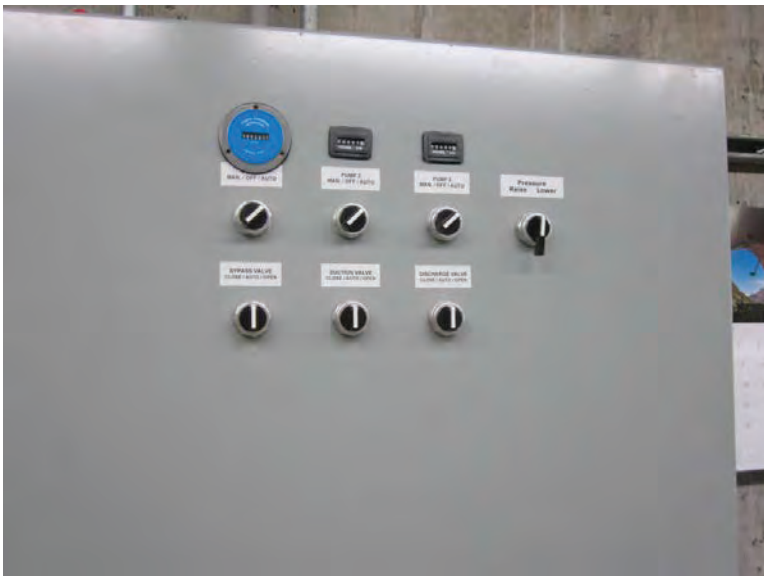
Photograph 67: Black Mountain booster pump controls

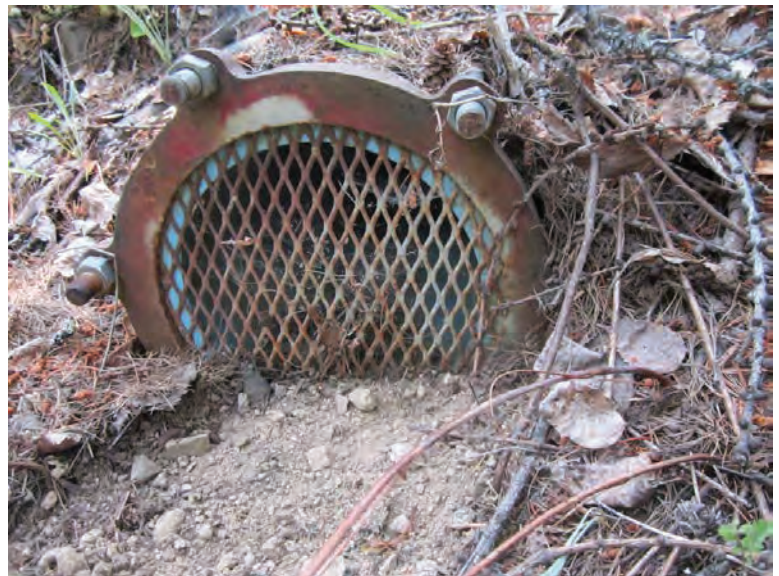
Photograph 68: Black Mountain reservoir screened drain

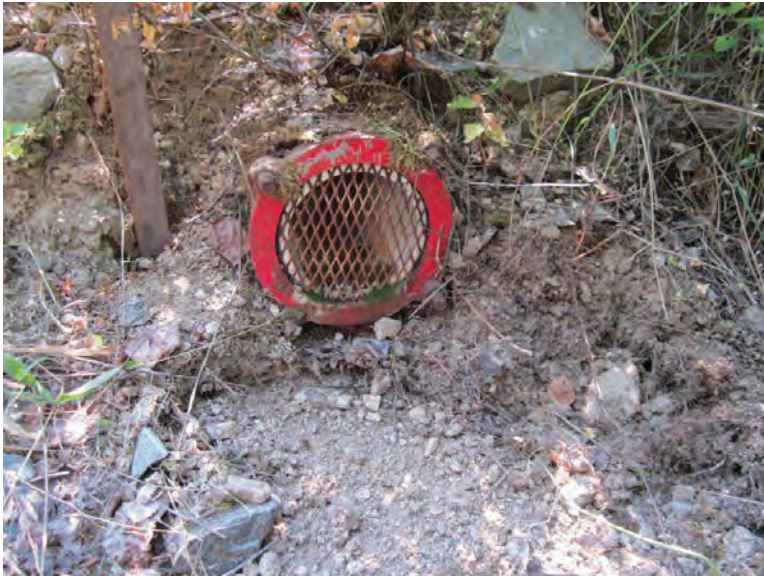
Photograph 69: Black Mountain reservoir screened overflow

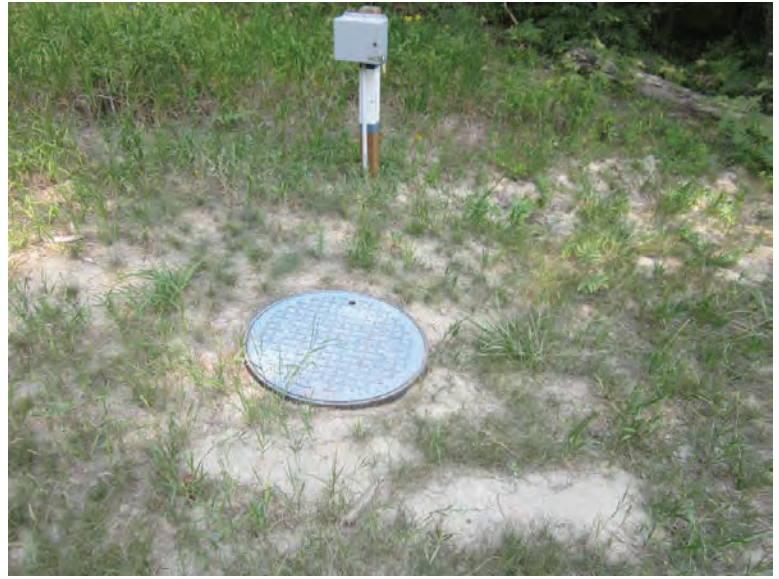
Photograph 70: Pressure reducing valve vault w pigtail

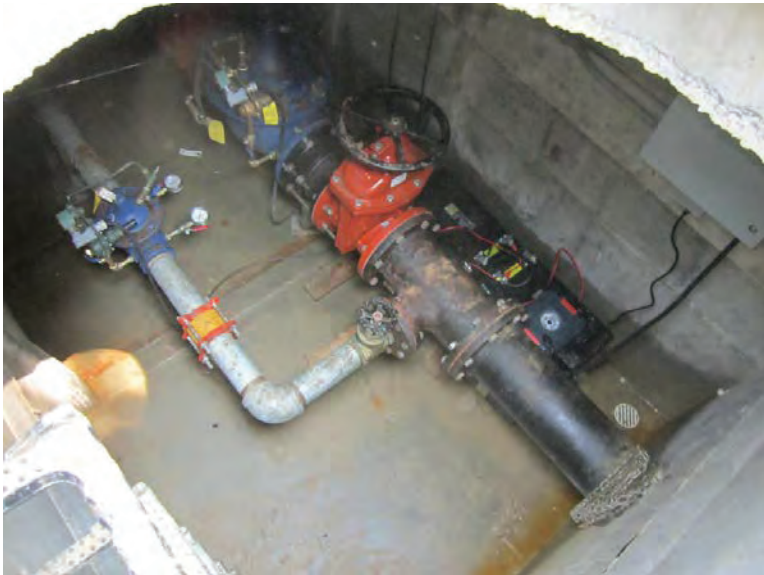
Photograph 71: Pressure reducing valve vault

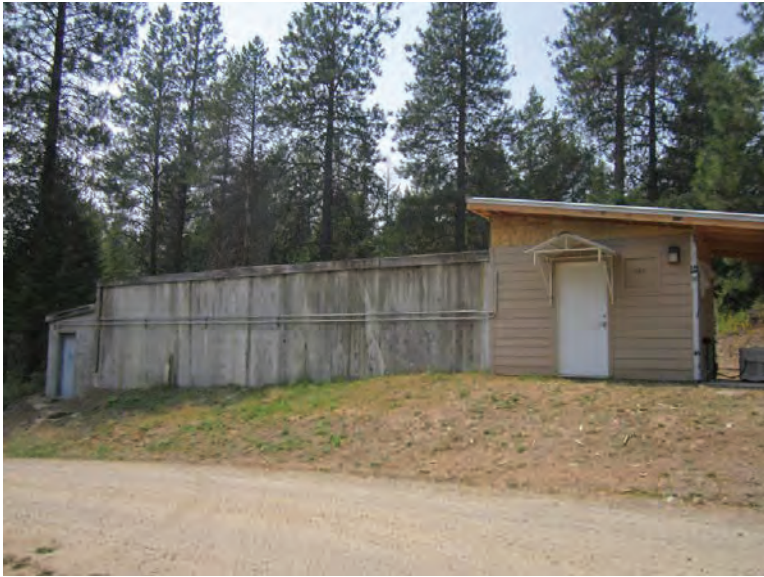
Photograph 73: Naples tank and booster station
