CABINET MOUNTAINS WATER DISTRICT

WATER SYSTEM FACILITY PLAN UPDATE

APRIL 2020

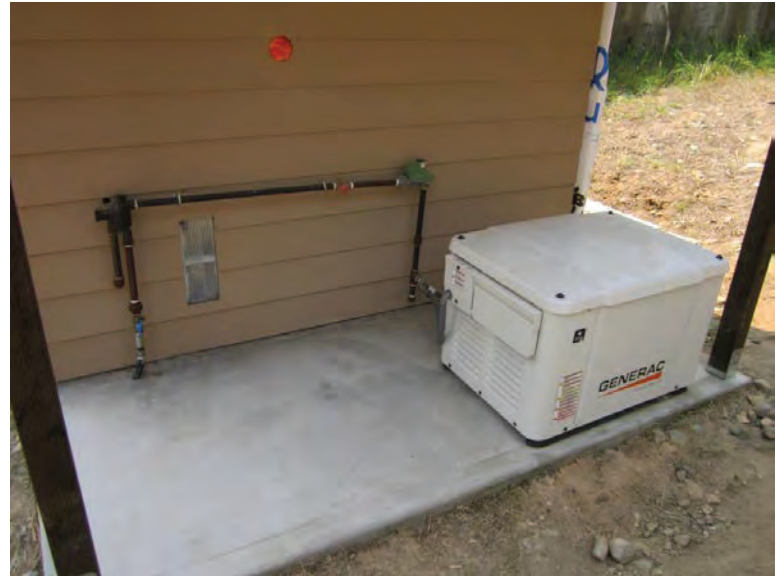
Photograph 74: Naples booster station propane generator

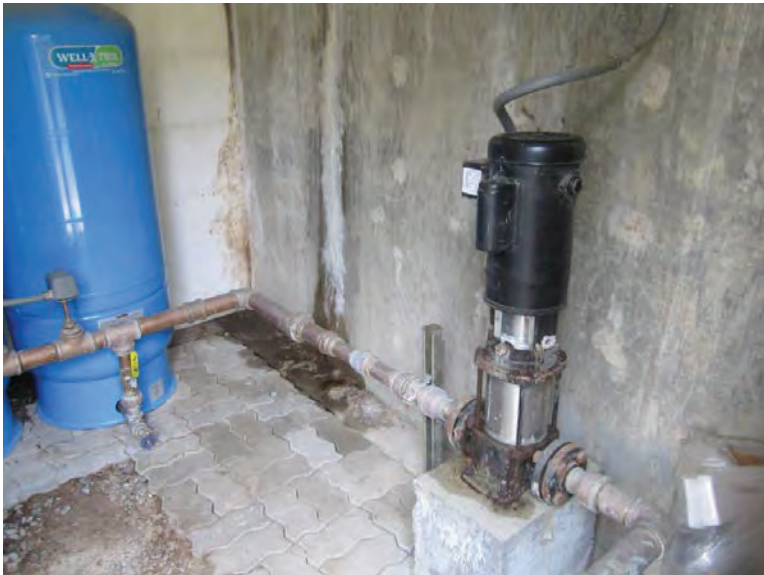
Photograph 75: Naples tank booster pump

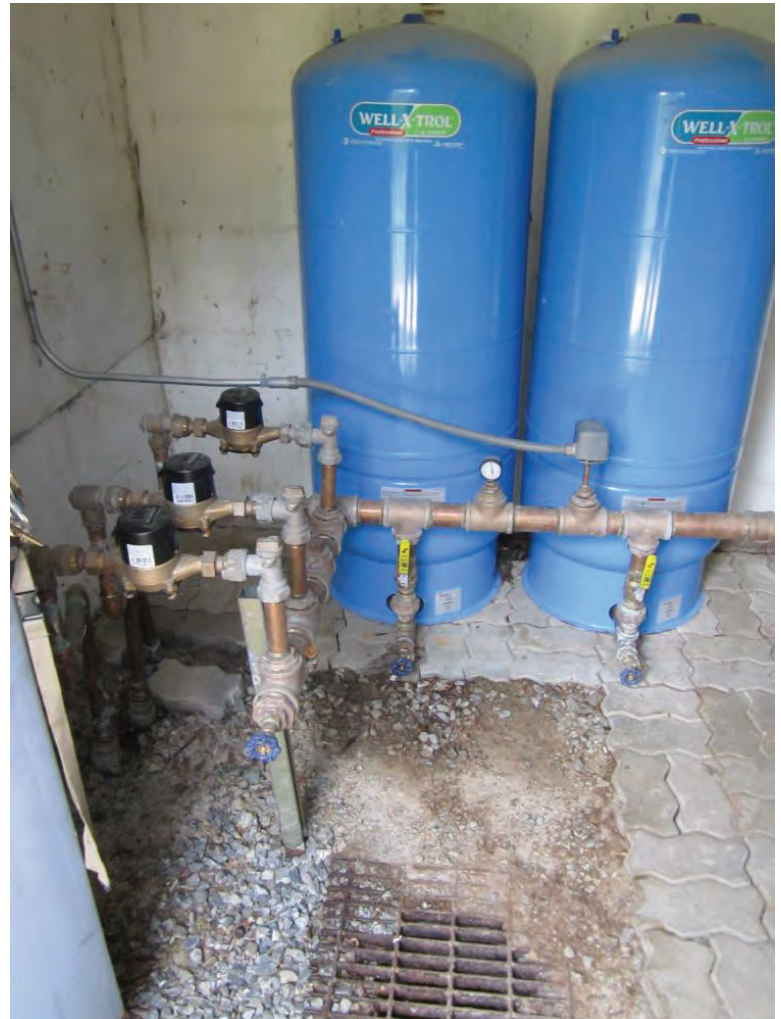
Photograph 76: Naples tank booster station, 3 residential connections

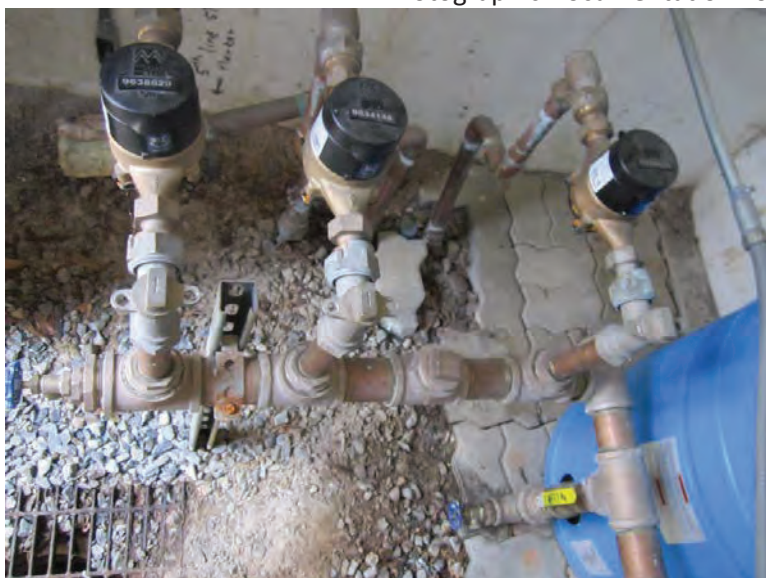
Photograph 77: Naples tank boosted discharge, 3 residential connections

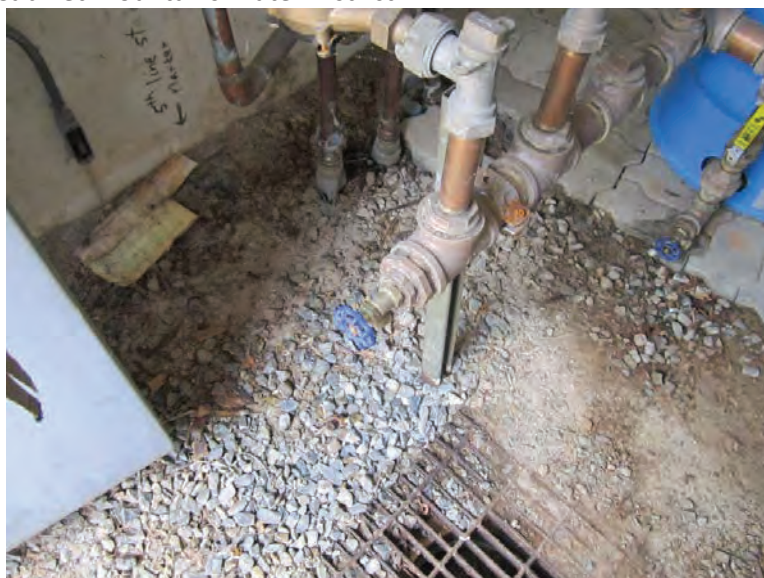
Photograph 78: Metered residential connection w corp stop

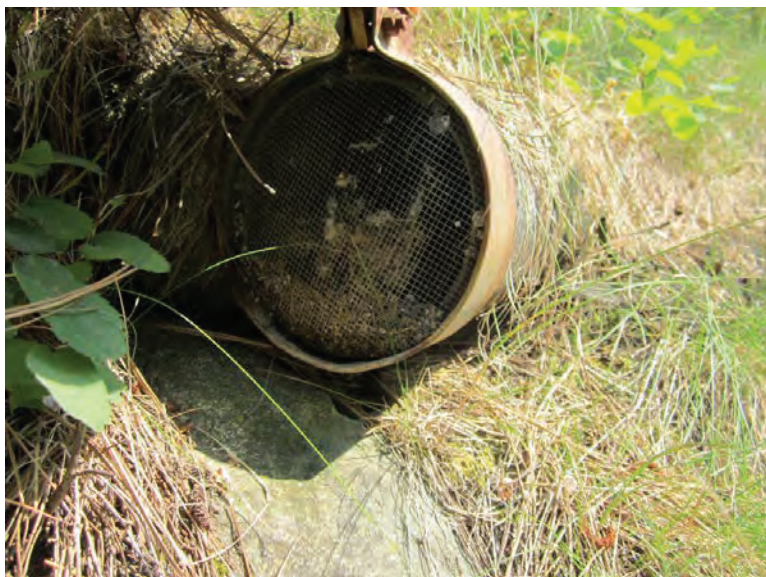
Photograph 79: Naples tank overflow outlet screened with metal flapper valve

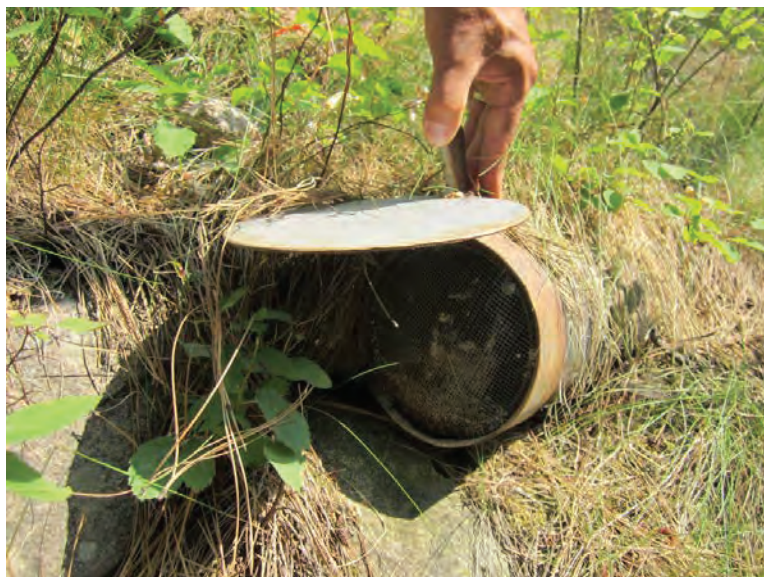
Photograph 80: Naples tank overflow outlet screened with metal flapper valve

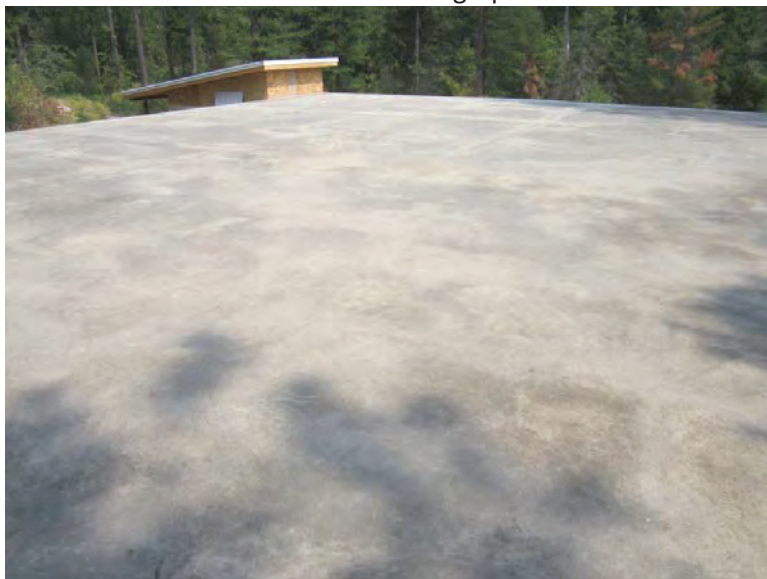
Photograph 81: Naples tank roof

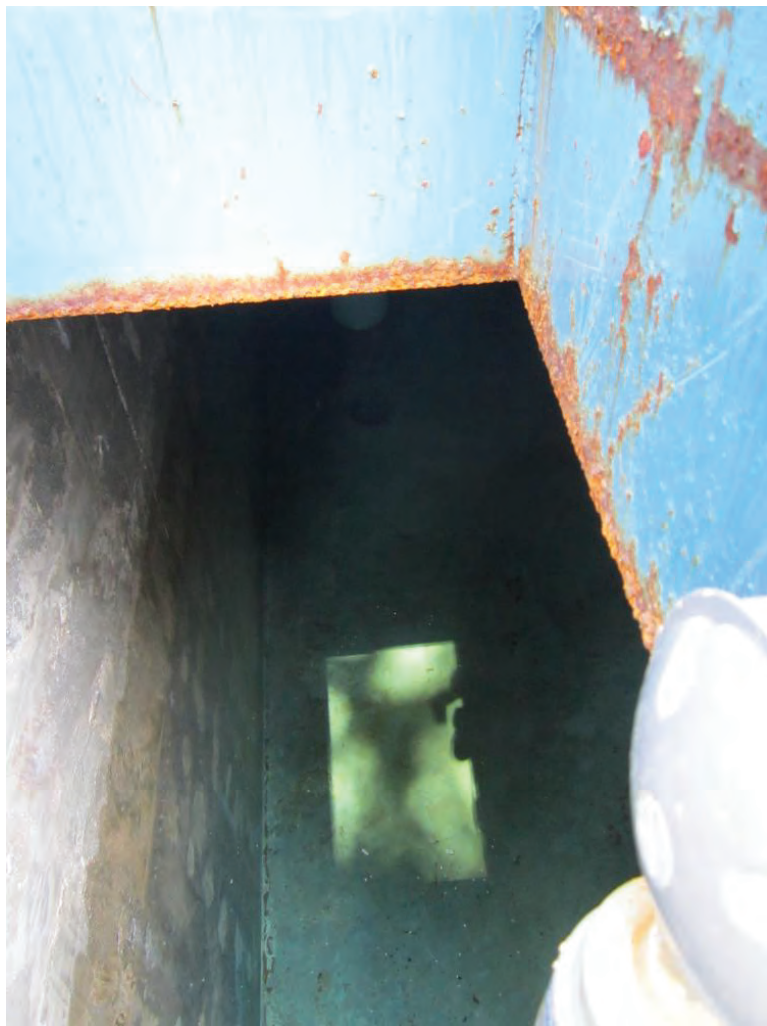
Photograph 82: Naples tank interior

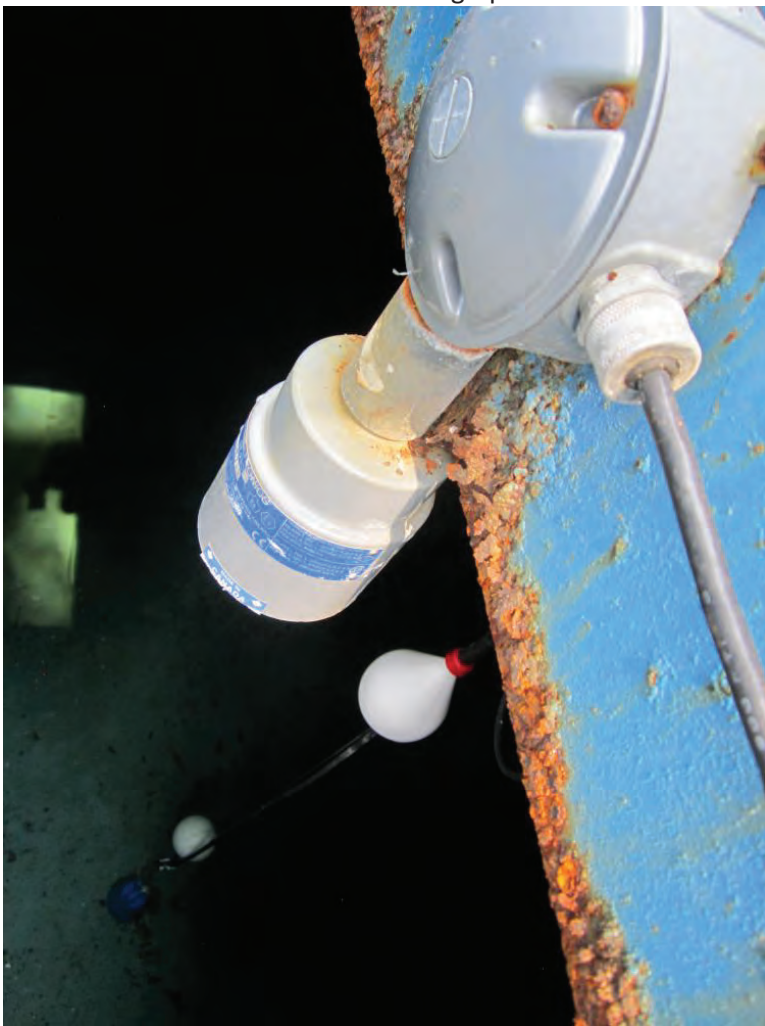
Photograph 83: Naples tank ultra-sonic level transducer

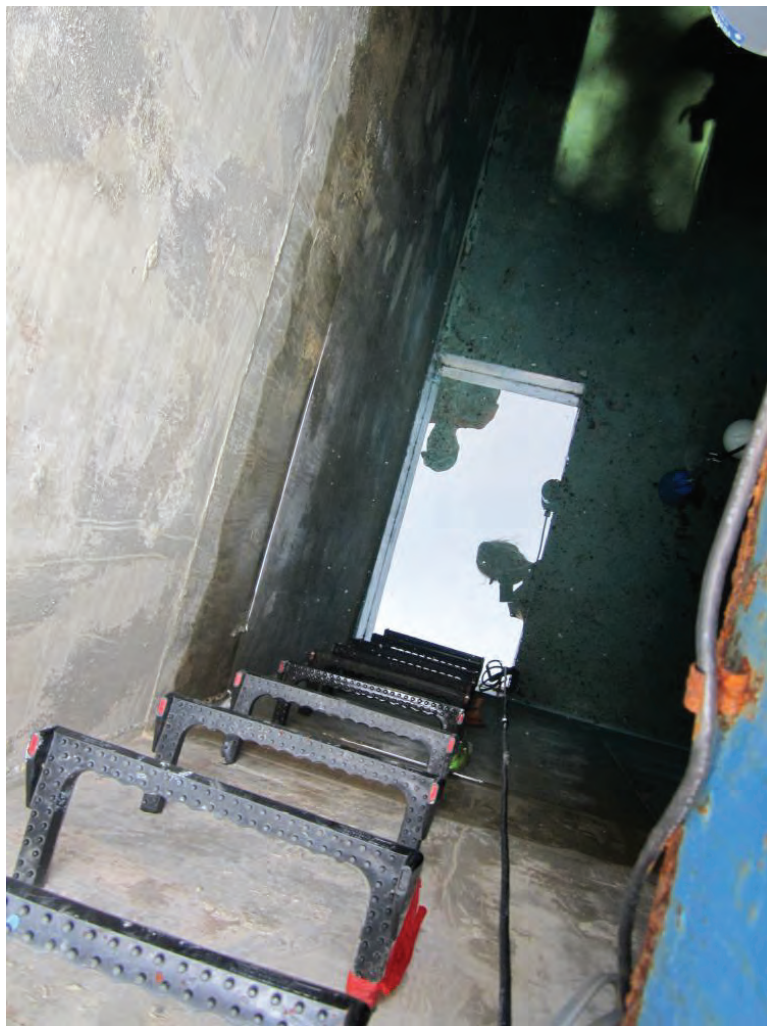
Photograph 84: Naples tank interior

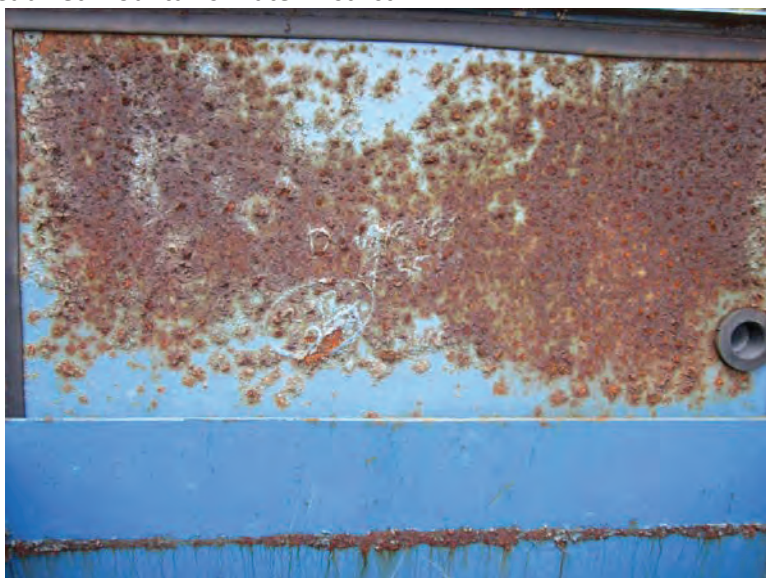
Photograph 86: Naples tank lid w water tight seal

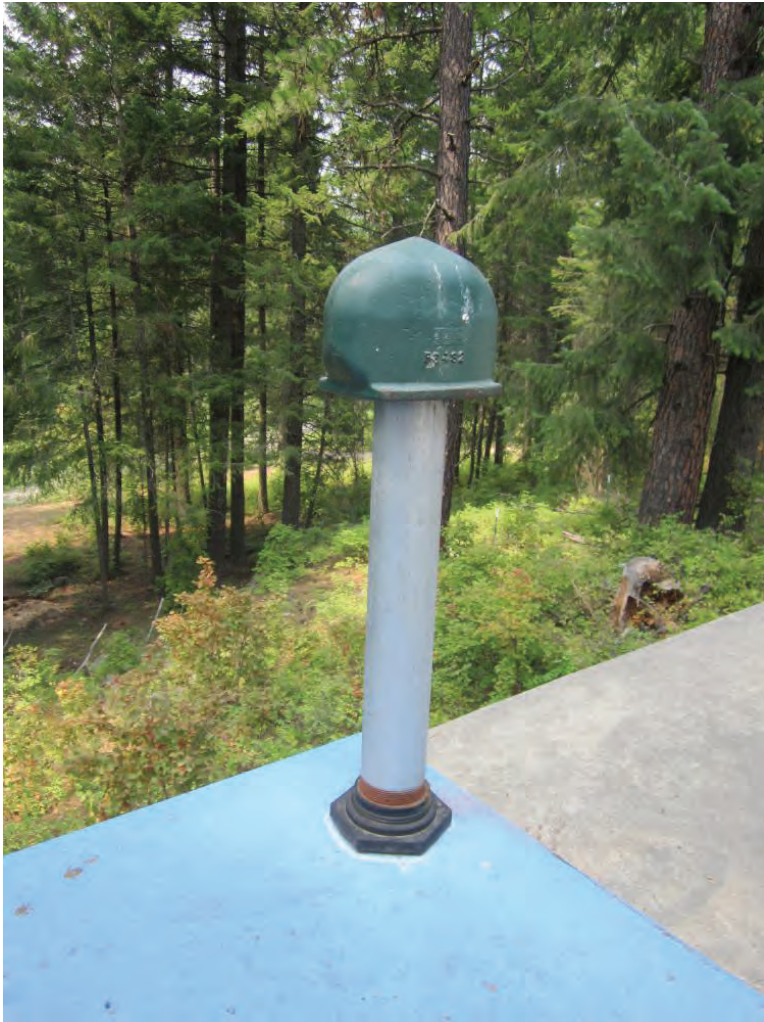
Photograph 87: Naples tank lid w screened vent

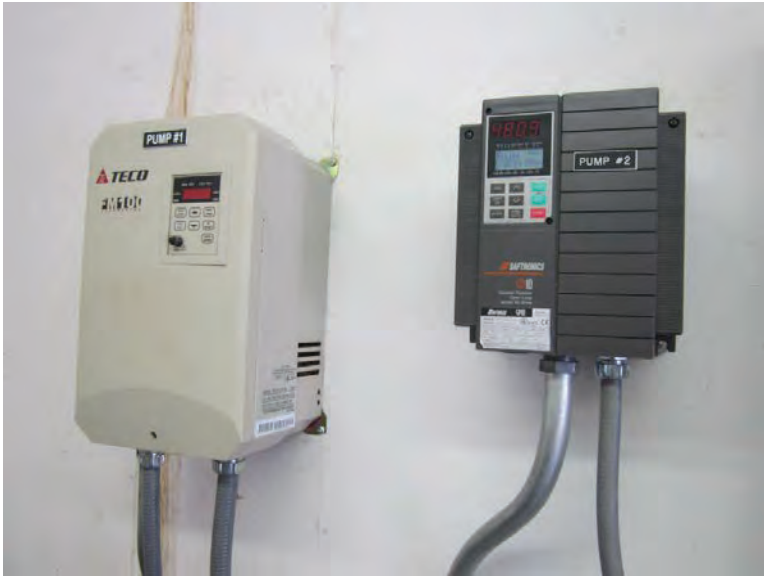
Photograph 91: Highland Flats booster pump controls

1.1	Highland Booster Replacement	\$586,000
1.2	Pump Station Improvements - Black Mountain Booster	\$179,000
1.3	Mountain Meadows Rd. Booster	\$285,000
1.4	Naples Pressure Reducing / Pressure Sustaining Valve	\$62,000

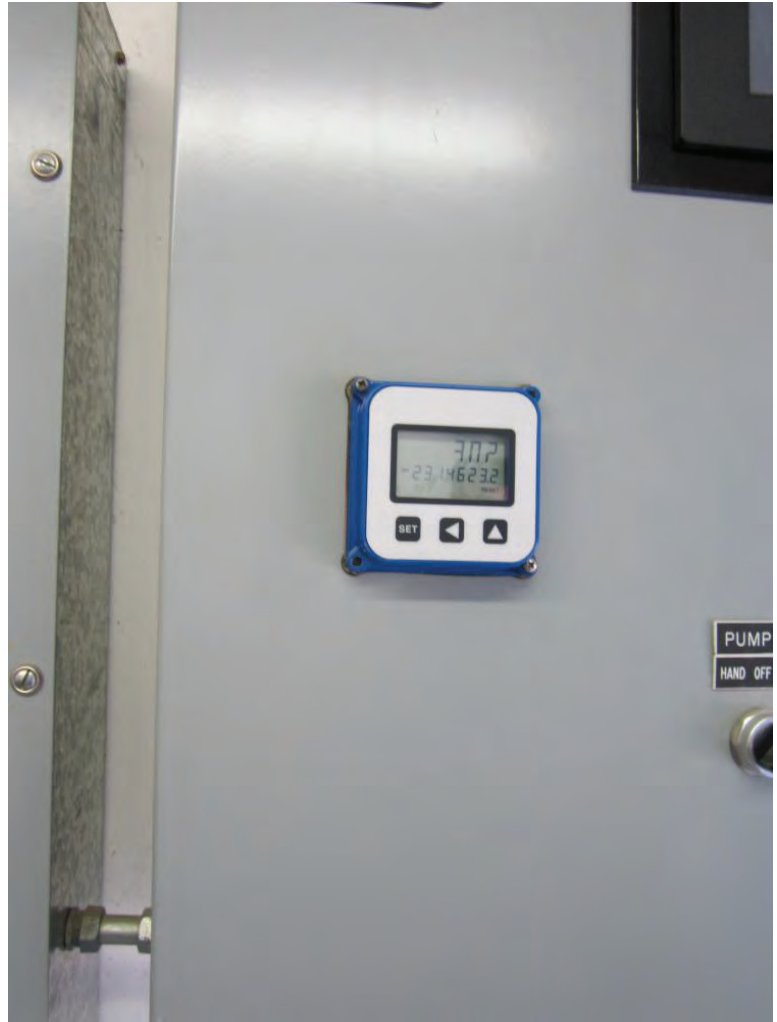
Photograph 92: Highland Flats flow meter (malfunctioning)

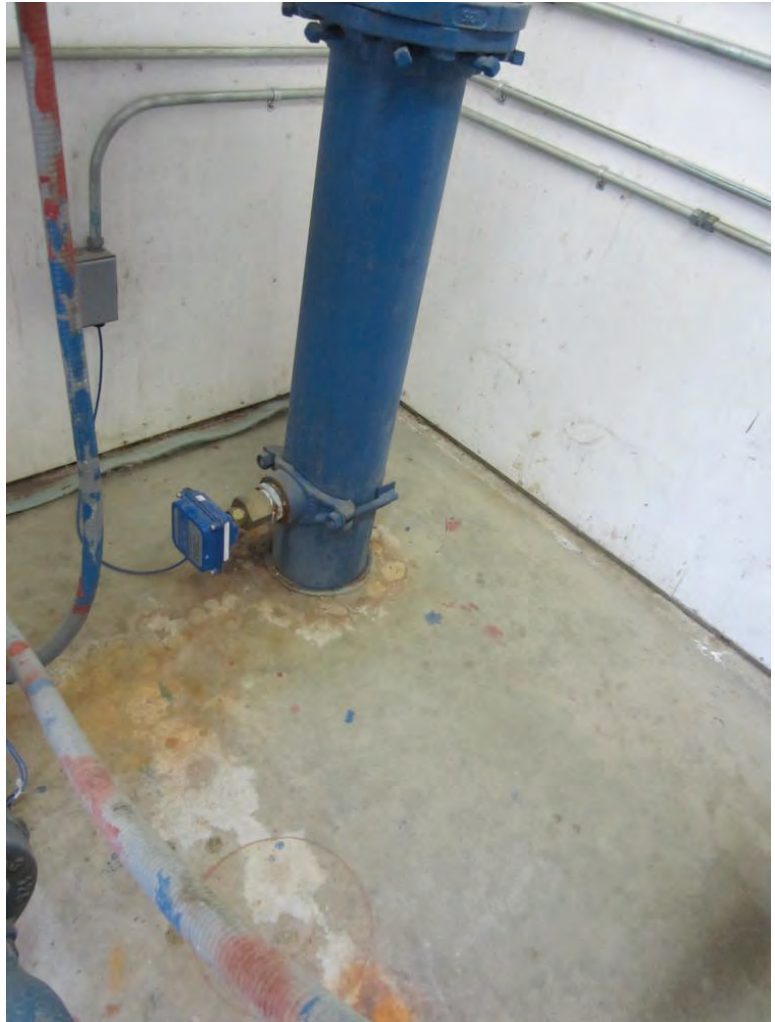
Photograph 94: Highland Flats combined boosted discharge flow meter

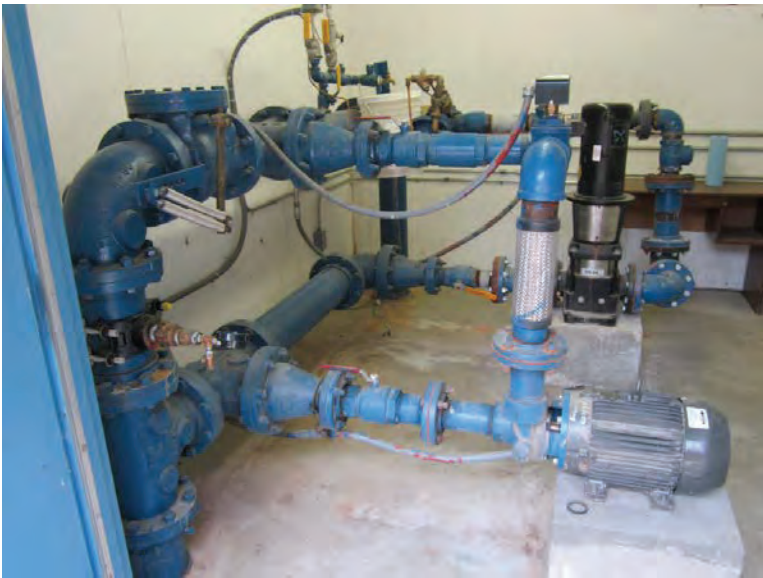
Photograph 95: Highland Flats boosted discharge appurtenances

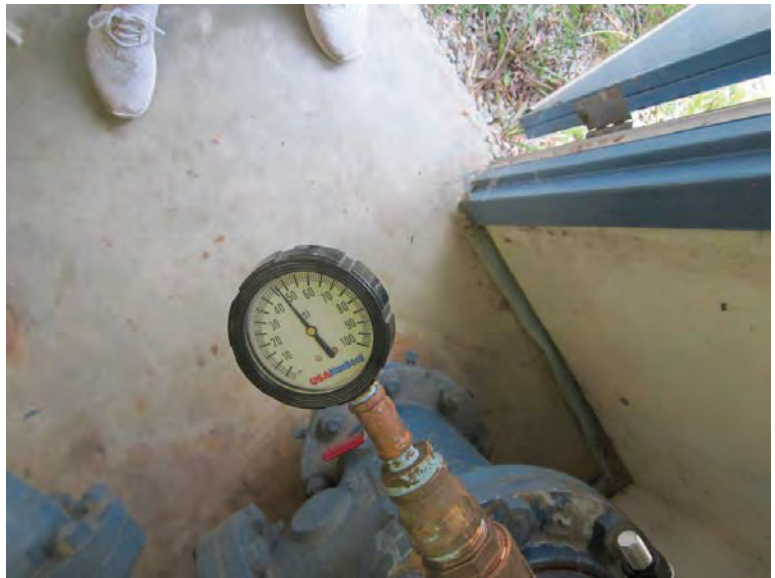
Photograph 96: Highland Flats inlet pressure
