CABINET MOUNTAINS WATER DISTRICT

WATER SYSTEM FACILITY PLAN UPDATE

APRIL 2020

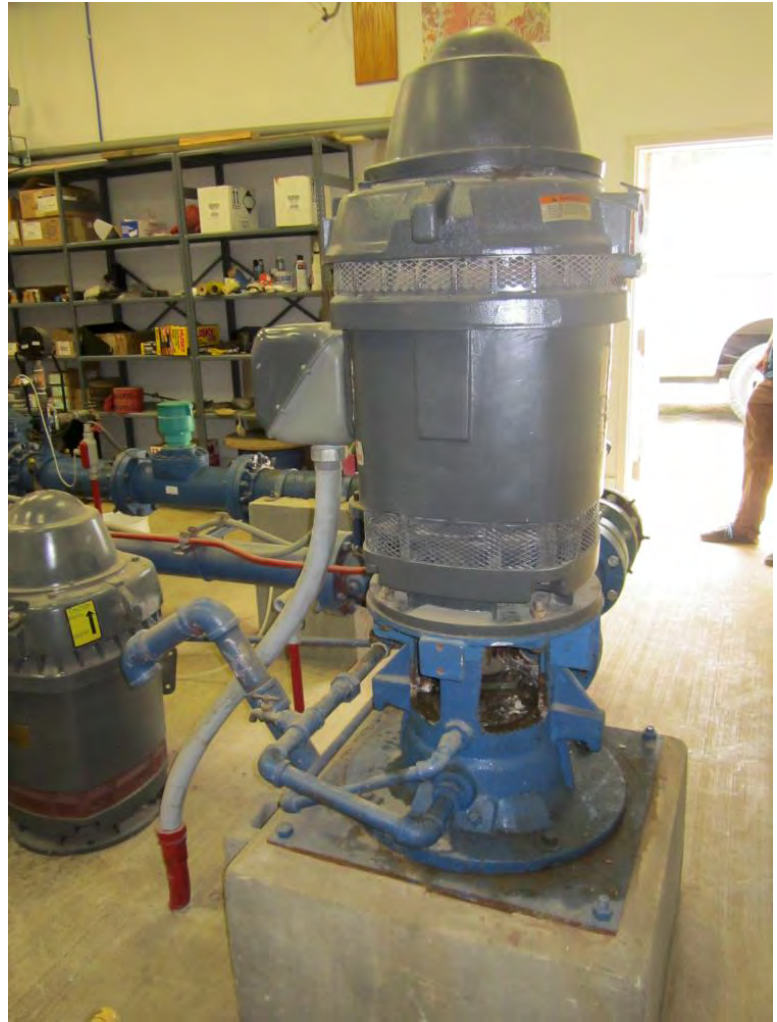
Photograph 2: Well 1

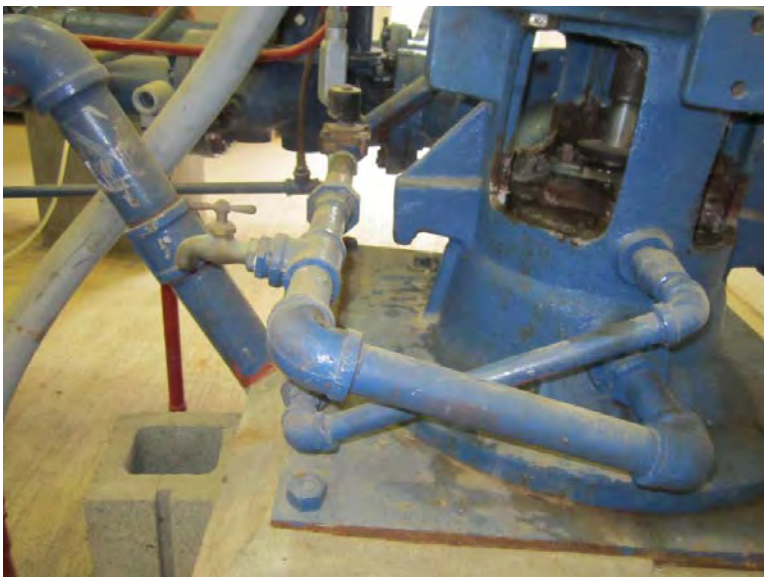
Photograph 3: Well 1 sample tap

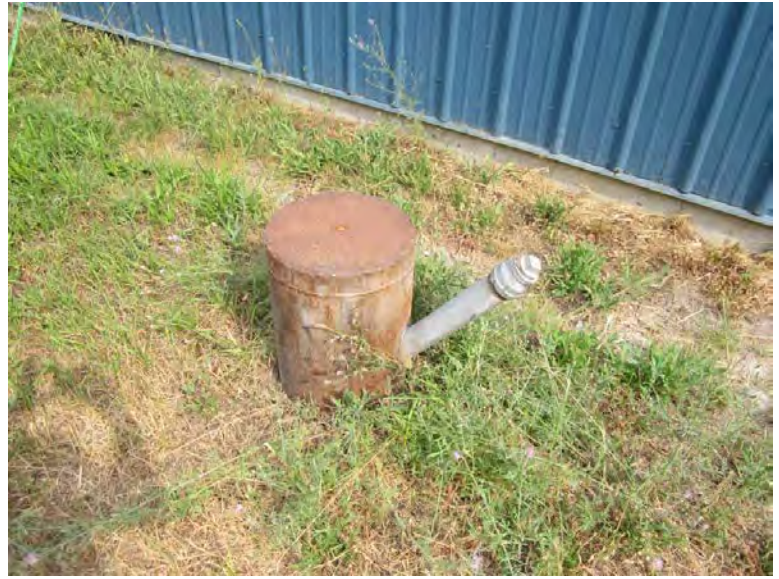
Photograph 6: Test well (capped)

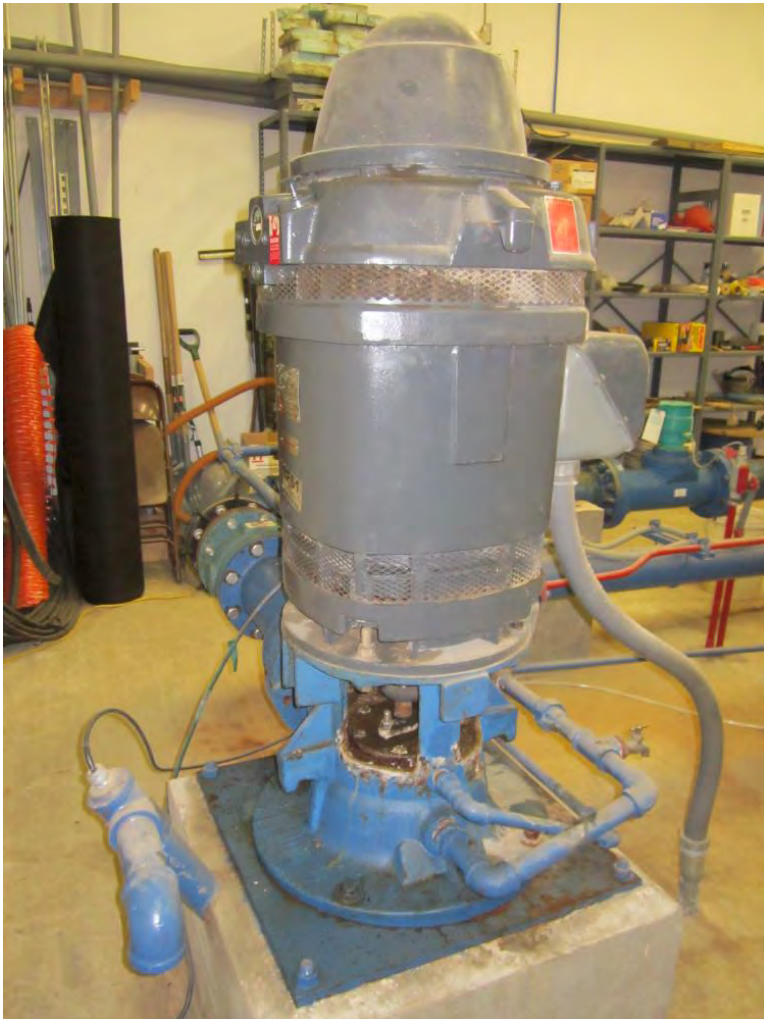
Photograph 7: Well 2

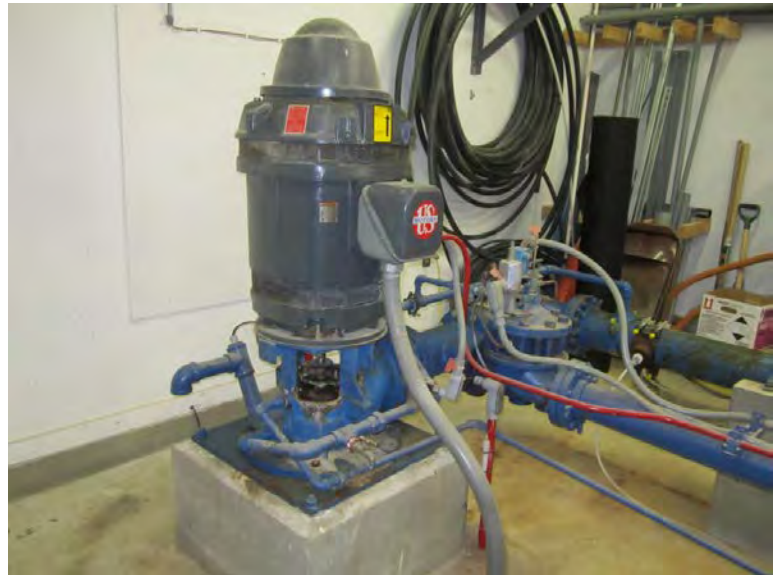
Photograph 8: Well 2

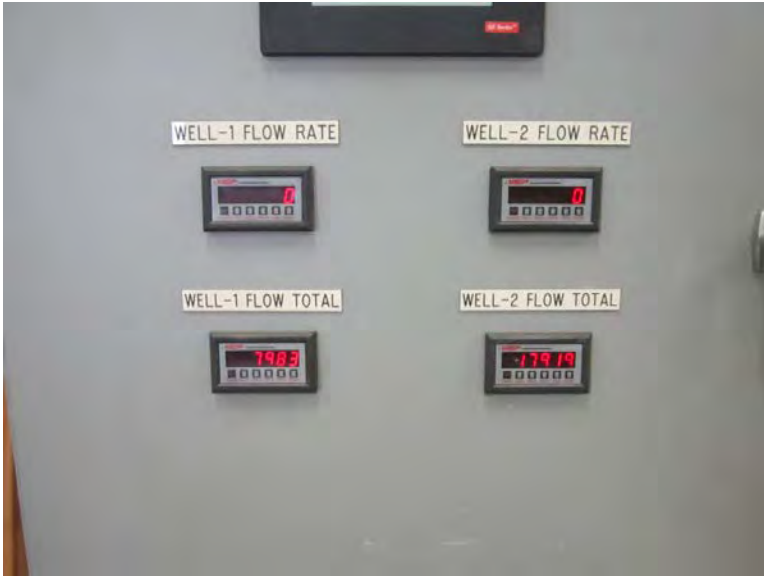
Photograph 21: Well flow rates

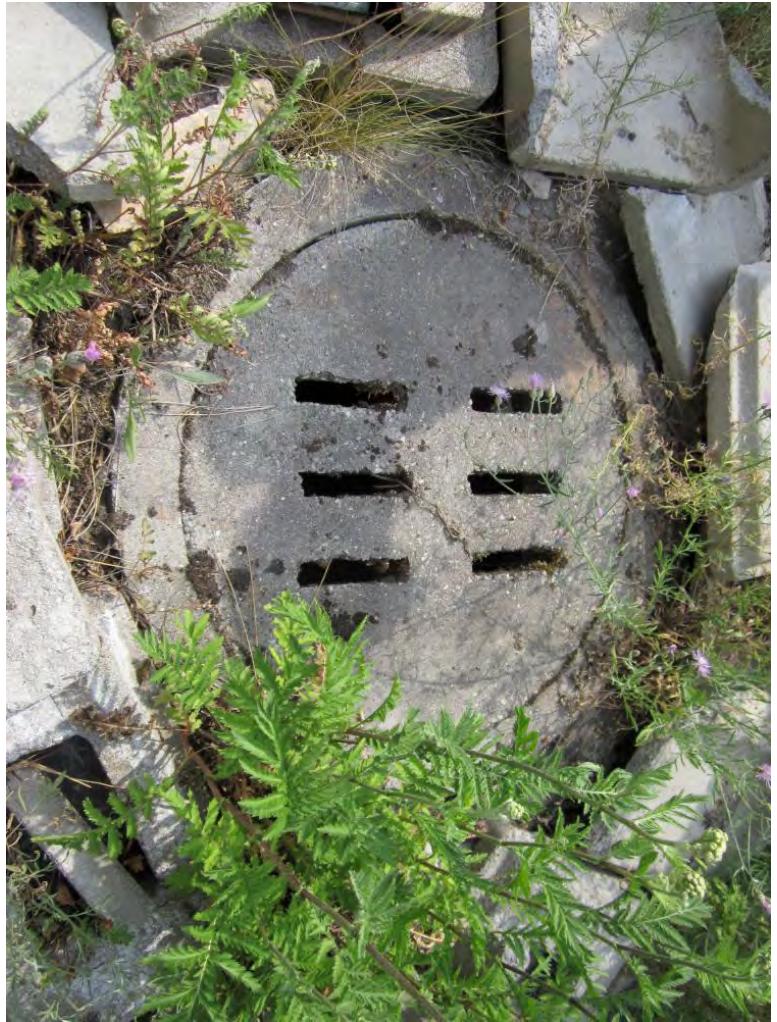
Photograph 22: Well discharge to waste dry well (requires air gap/backflow protection)

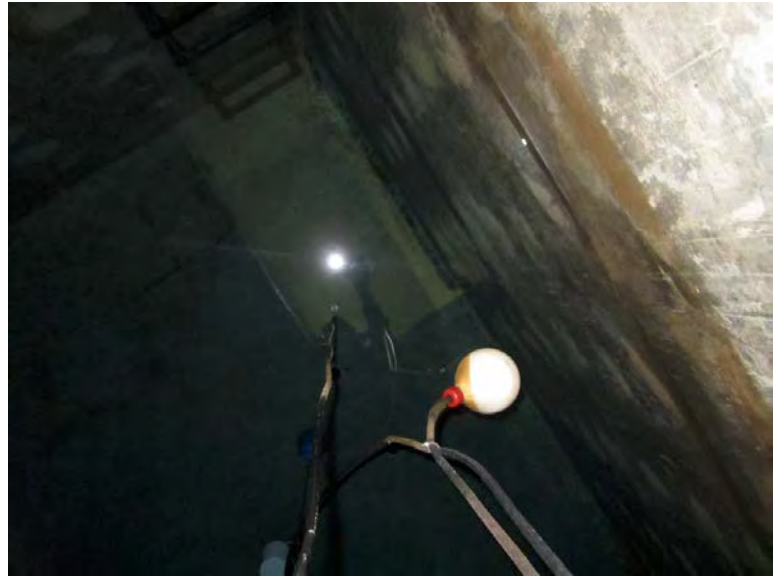
Photograph 26: Parker Canyon tank

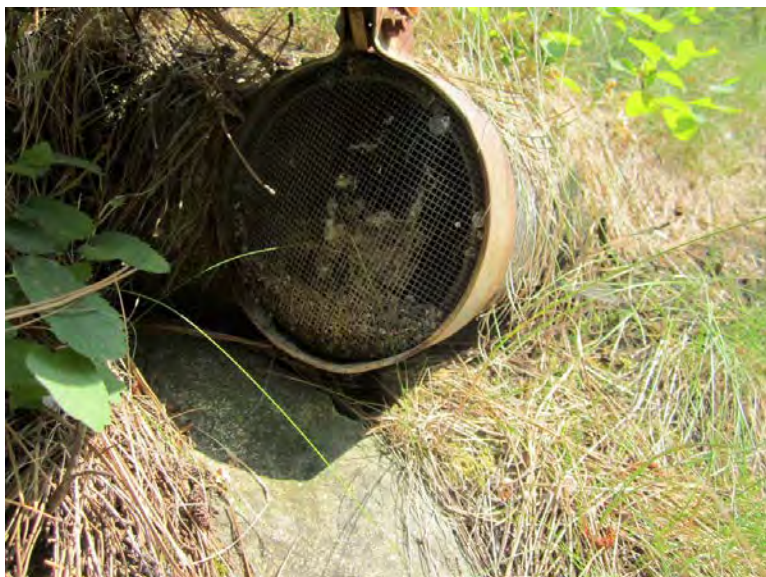
Photograph 79: Naples tank overflow outlet screened with metal flapper valve

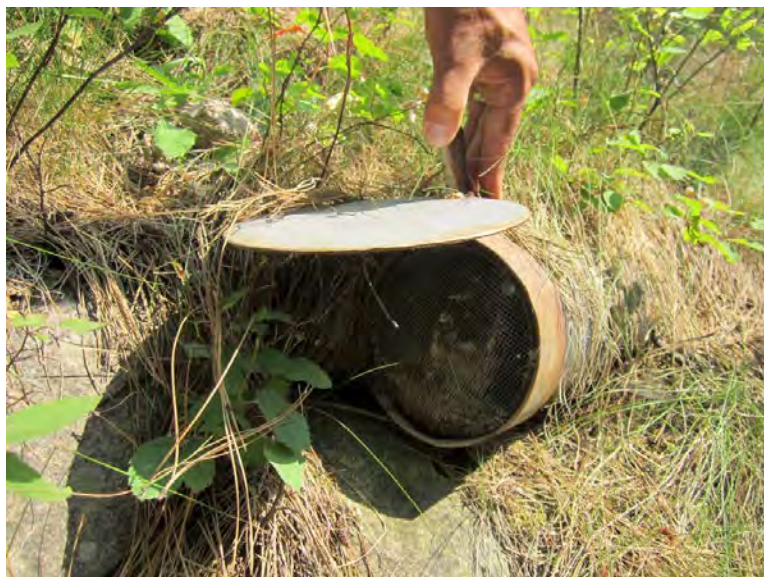
Photograph 80: Naples tank overflow outlet screened with metal flapper valve

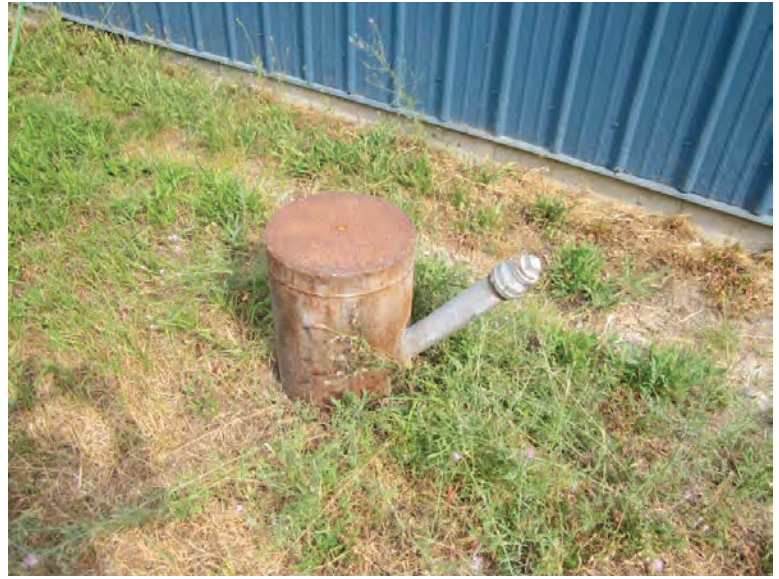
Photograph 6: Test well (capped)

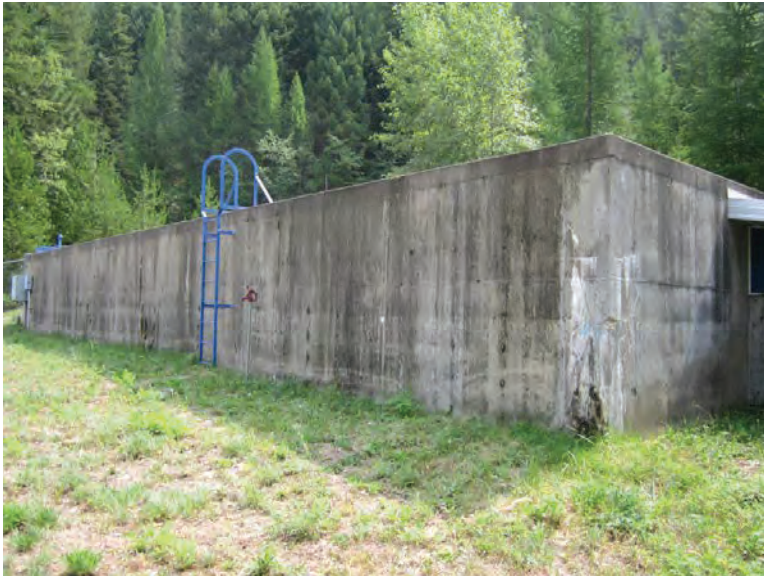
Photograph 57: Black Mountain reservoir

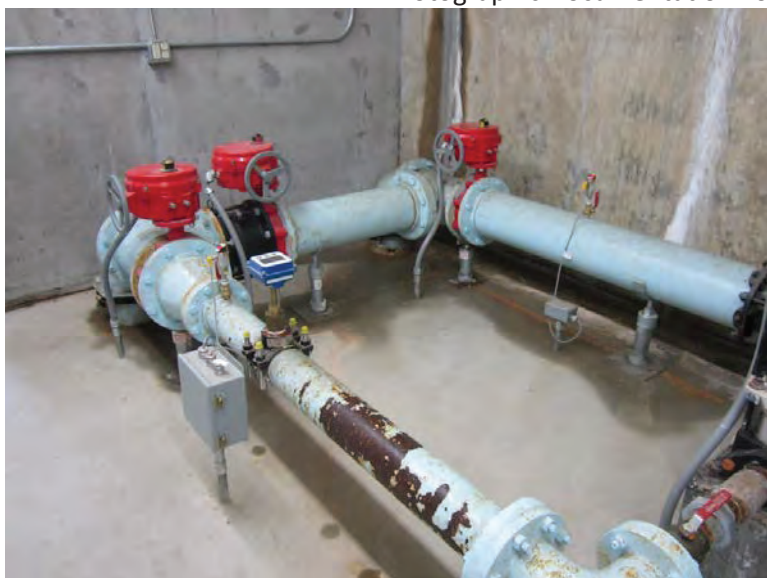
Photograph 61: Black Mountain reservoir fill line and boosted discharge appurtenances

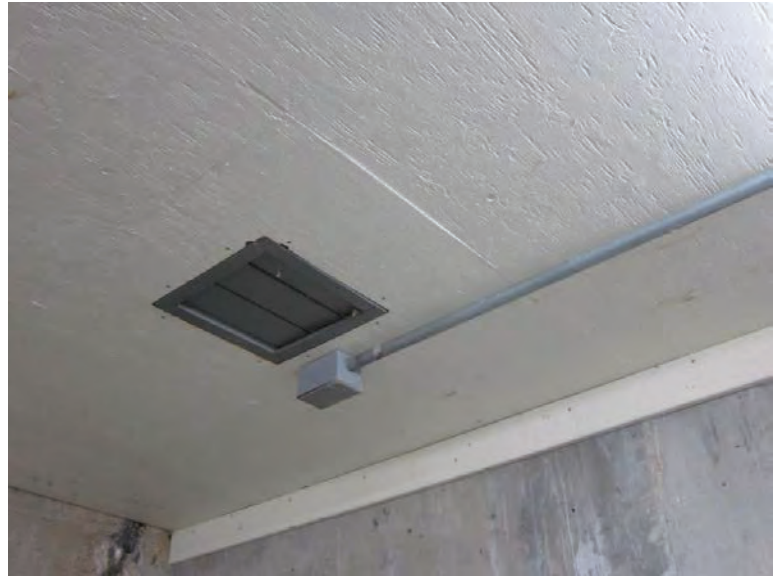
Photograph 66: Black Mountain booster station, thermostatically controlled louvre vent

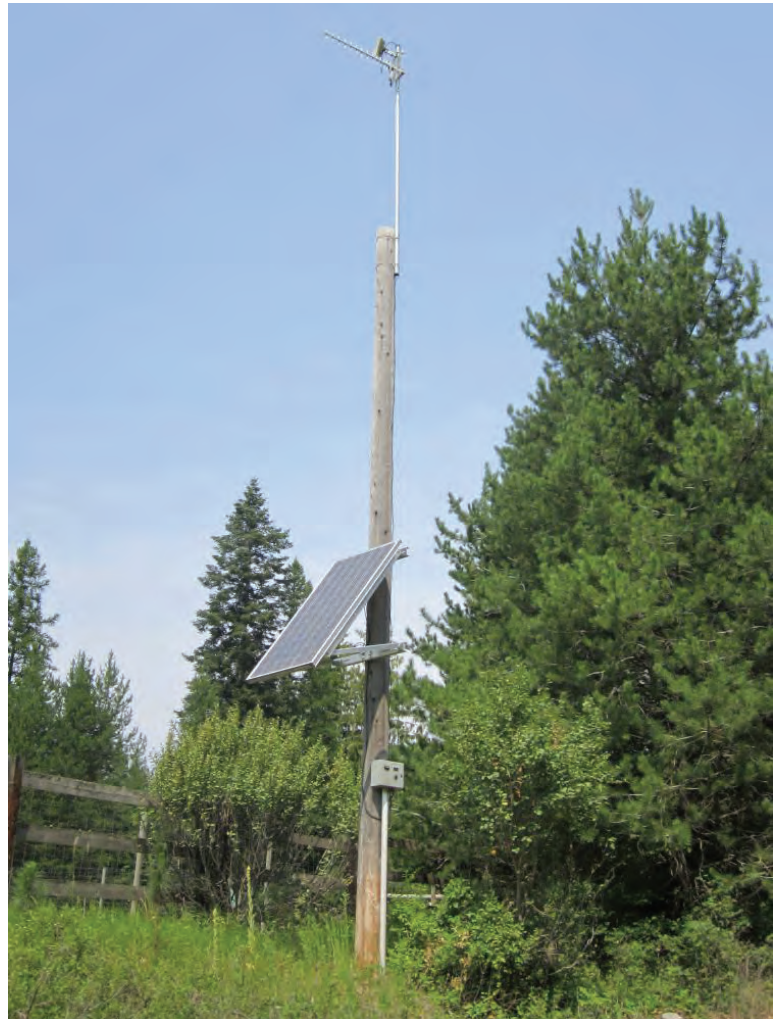
Photograph 72: Pressure reducing valve solar panel to charge batteries

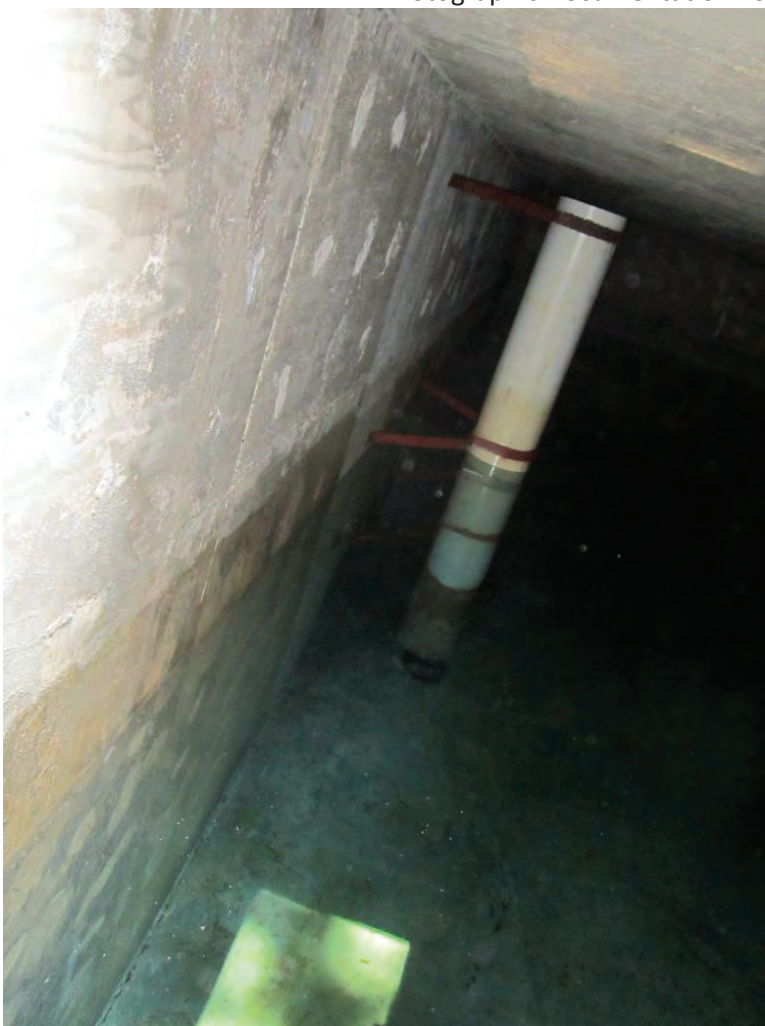
Photograph 85: Naples tank overflow

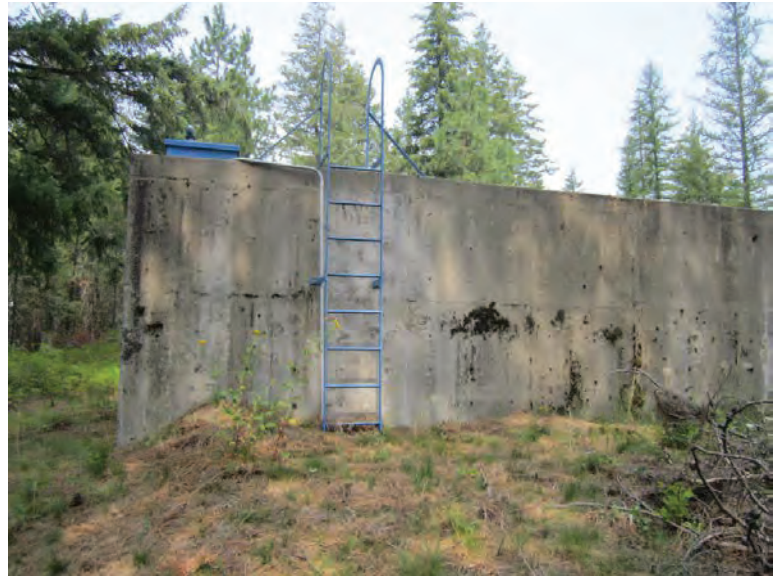
Photograph 88: Naples tank

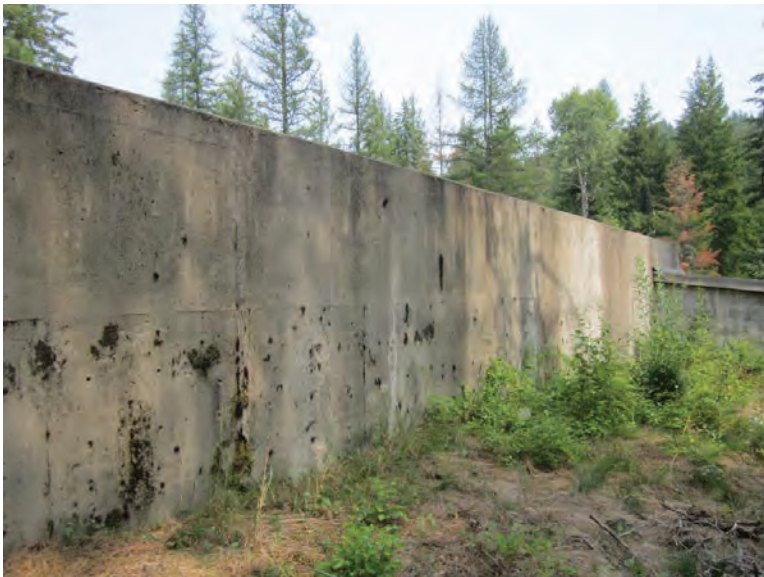
Photograph 89: Naples tank

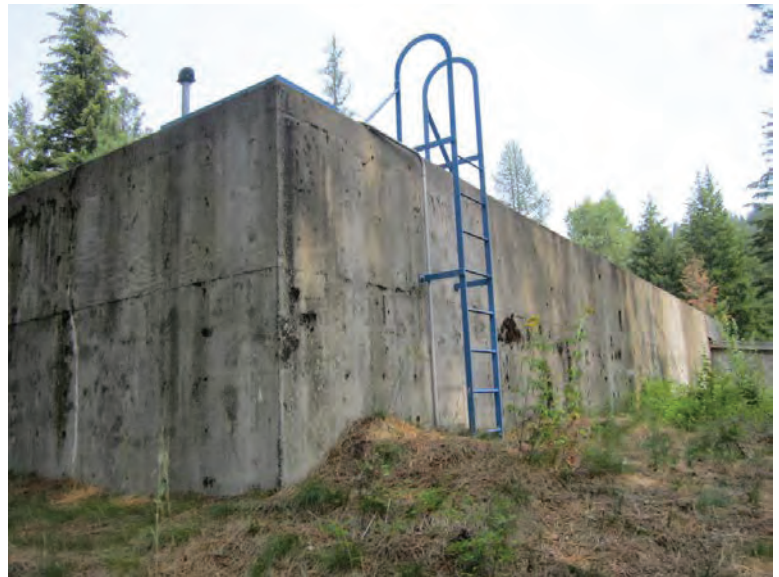
Photograph 90: Naples tank

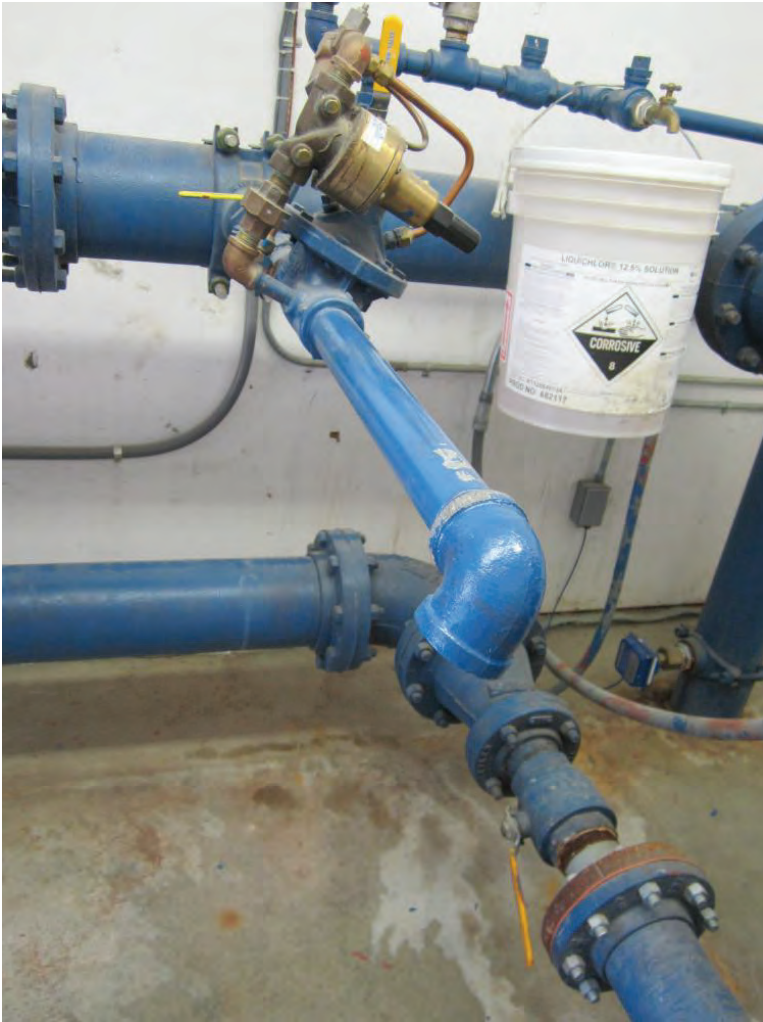
Photograph 93: Highland Flats pressure relief (requires reconfiguration of discharge)

1.1	Highland Booster Replacement	\$586,000
1.2	Pump Station Improvements - Black Mountain Booster	\$179,000
1.3	Mountain Meadows Rd. Booster	\$285,000
1.4	Naples Pressure Reducing / Pressure Sustaining Valve	\$62,000
